Your Inspection Report

Some where in BC
My Village, BC

INSPECTION DATE:
Sunday, February 14, 2021

RE: Report No. 1061
Some where in BC
My Village, BC

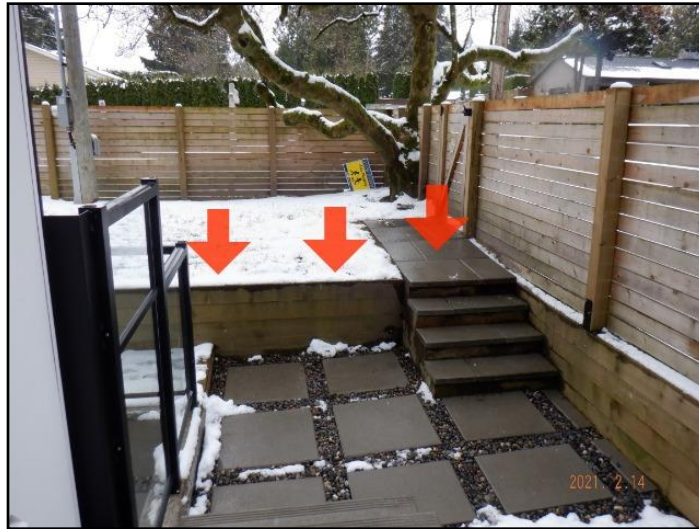
11. Missing

2. Condition: • [Missing](#)

Please provide railing and hand rails along the retaining wall and the steps at the front.

Implication(s): Fall hazard

Task: Provide railings

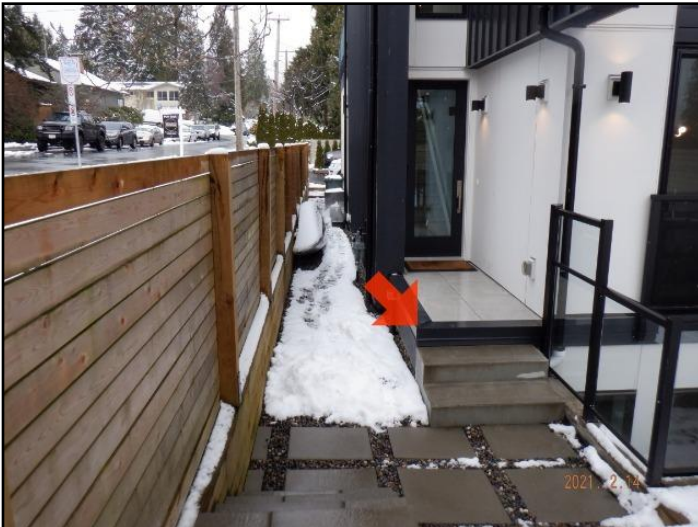
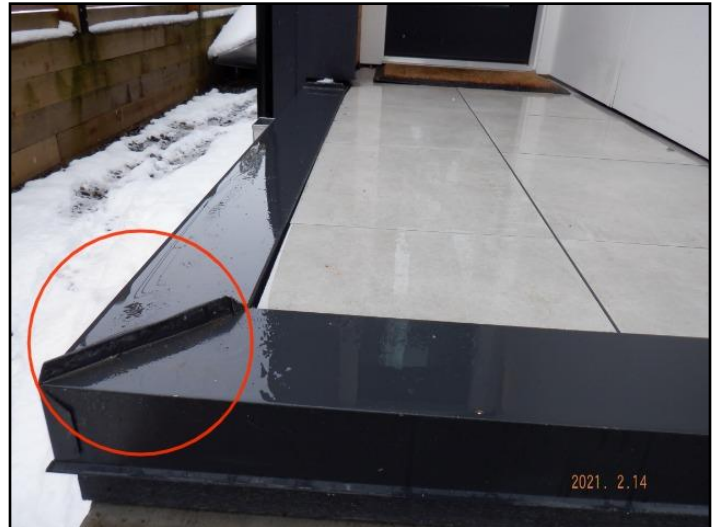
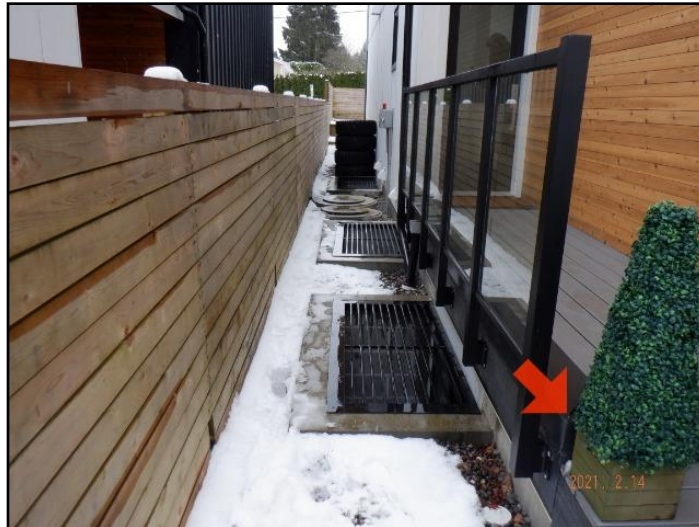
Condition: • The "standing" seam on the metal flashing at the front and the rear of the house is at an awkward location and presents a major trip and injury hazard.

3. Condition: • The "standing" seam on the metal flashing at the front and the rear of the house is at an awkward location and presents a major trip and injury hazard.

The choice of the material and method of installation should be improved on, or protection provided to the occupants from the seam.

Implication(s): Trip hazard / Injury hazard

Task: Improve or Protect.

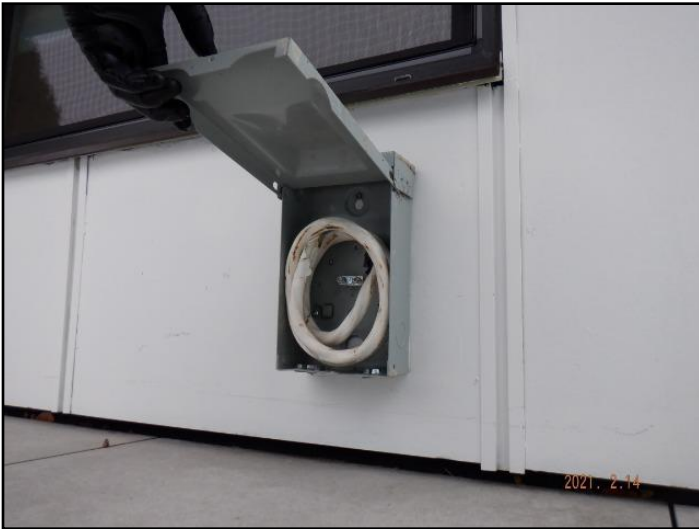
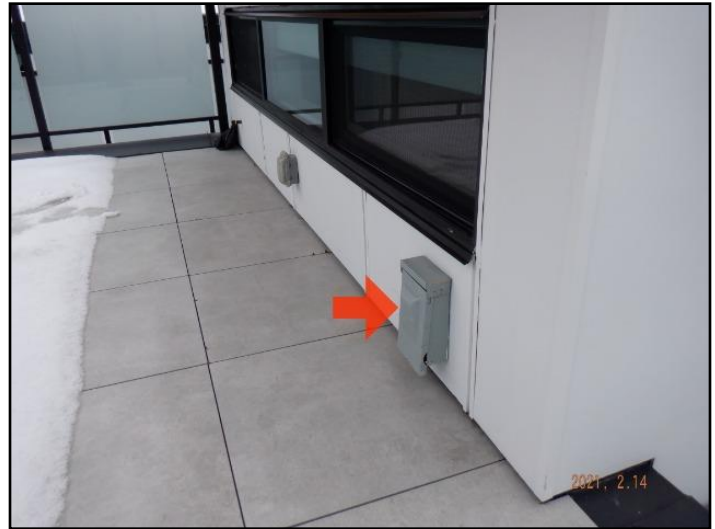
4. Condition: • It appears the roof has the option of attaching a central air conditioning unit Or a hot tub. Please confirm with the seller before closing regarding the wiring provided.

Implication(s): Electrocutation hazard.

Have an electrician isolate the wires properly if not in use.

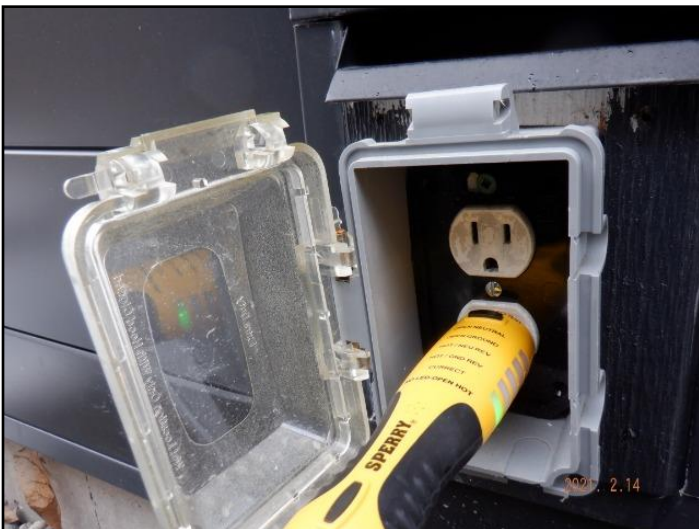
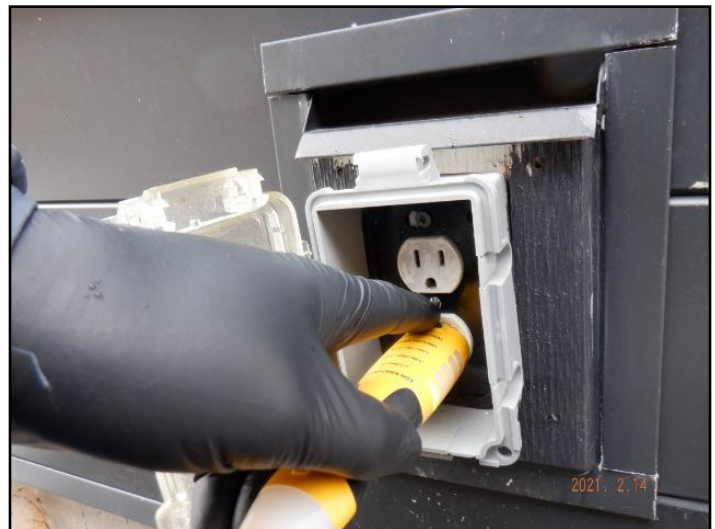
23. GFCI/GFI needed (Ground Fault Circuit...

6. Condition: • [GFCI/GFI needed \(Ground Fault Circuit Interrupter\)](#)

One of the exterior outlets is not GFCI protected. Recommend replacing it with a GFCI outlet as per current standards of building.

Implication(s): Electric shock

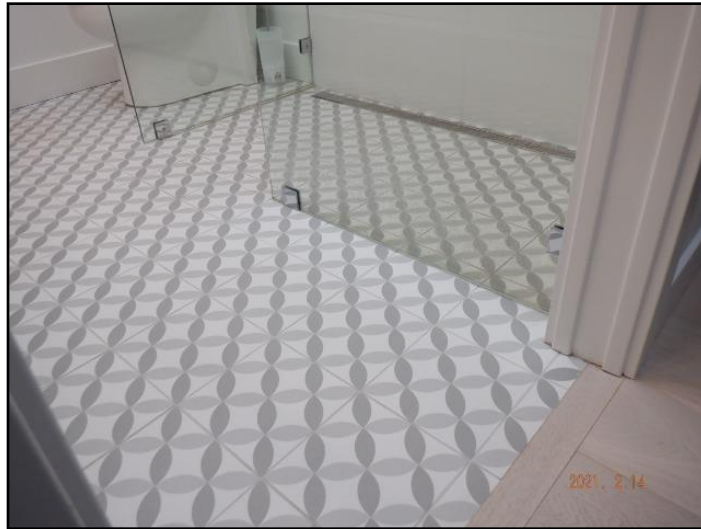
8. Condition: • The shower floors are "NO SILL" floors, that means any blockage of the drain will cause the water to spill into living space. It is imperative to keep the drains in proper working order to avoid flooding risk.

Implication(s): Flooding risk causing damage to structure and contents.

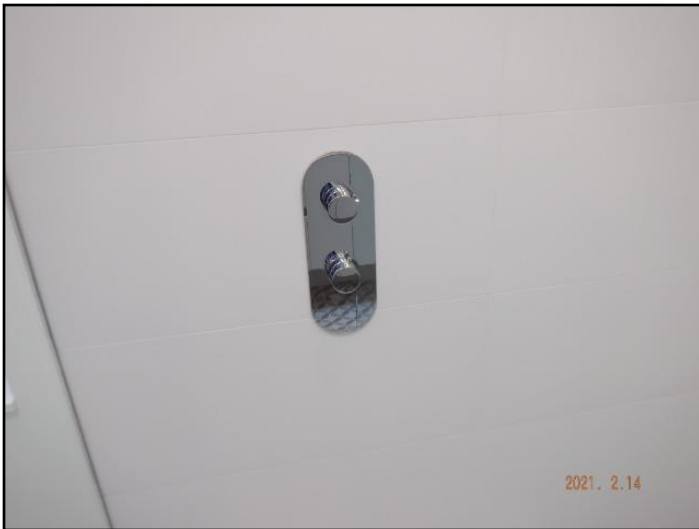
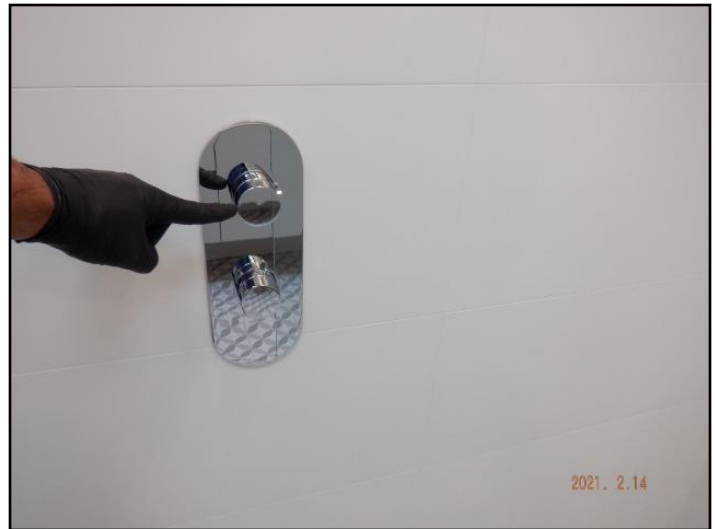
35. Loose

9. Condition: • [Loose](#)

Faucet appears to be loose, missing sealant.

Implication(s): Equipment failure

Task: Provide caulking

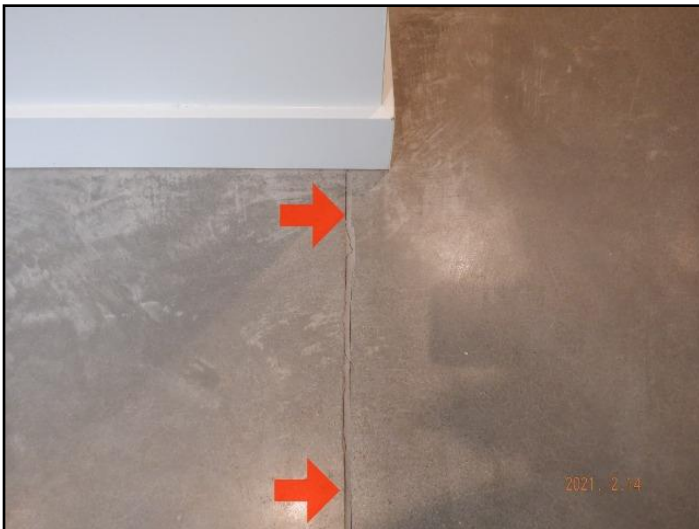
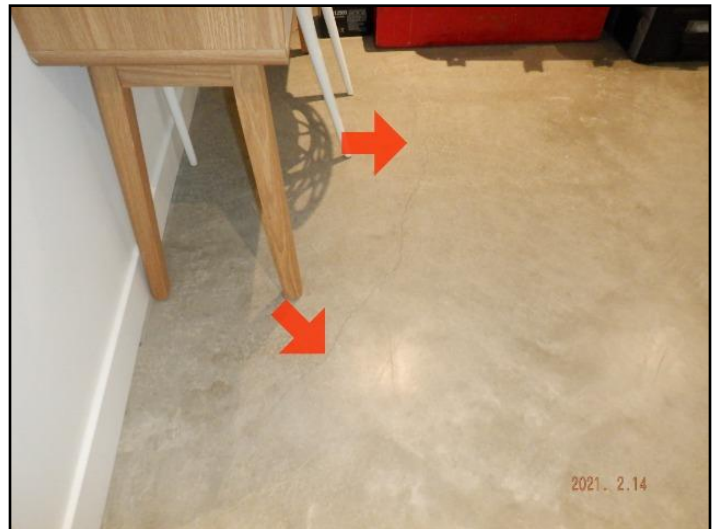
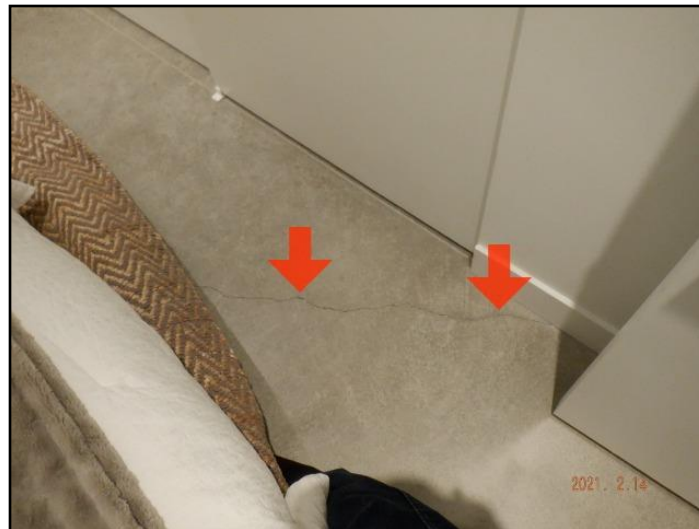
38. Cracked

10. Condition: • [Cracked](#)

Minor cracks in the finished concrete floor at several locations.

Implication(s): Trip or fall hazard | Difficult access

Task: Seal and protect
