# INSPECT360 HOME INSPECTIONS

1234 Main Street  
Port Coquitlam, BC V3B5T8

11/25/2025 9:00AM

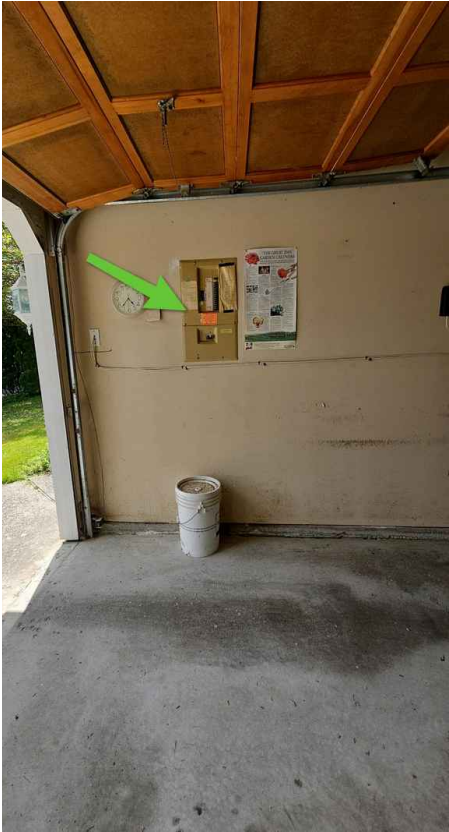
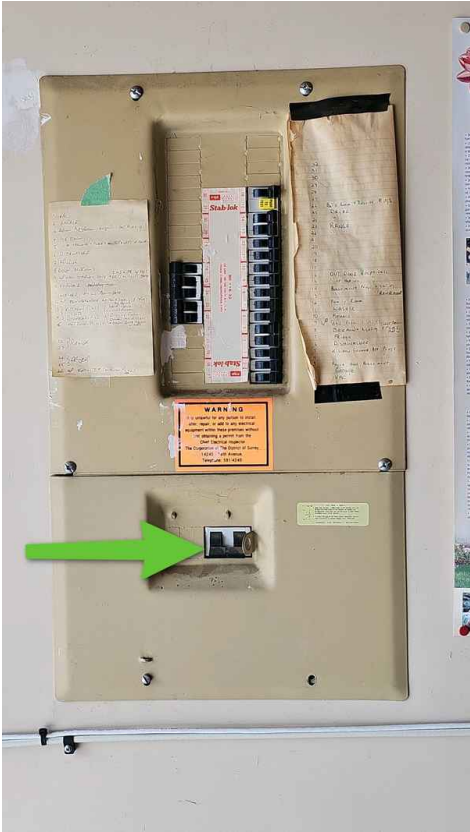
**Main Electrical Shutoff: Location**  
Garage

In case of an Electrical Emergency trip the MAIN BREAKER to shut off power for the entire house.

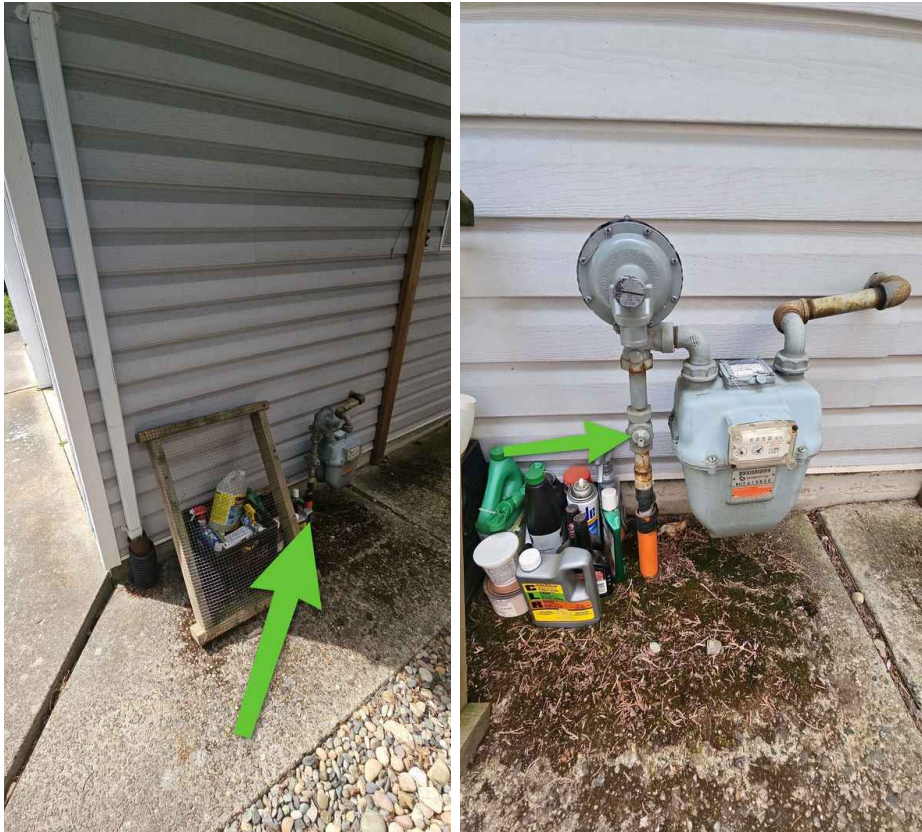
**Gas Shutoff: Location**

Exterior Wall.

- Leave the building or area immediately. As you exit, leave open any windows and doors.
- Leave lights and appliances alone as they may be a source of ignition.
- Call 911 from a safe location.
- Shut off the gas at the meter if able to. (Turn the valve 90 Degrees)

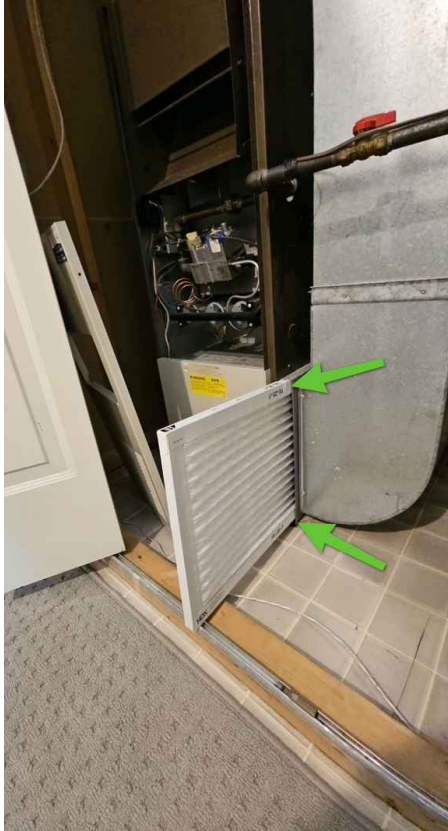
**Furnace Switch: Furnace Filter**

16x25x1

Replace Furnace Filter Every 3 months.

Service furnace yearly for best performance and maximum life.

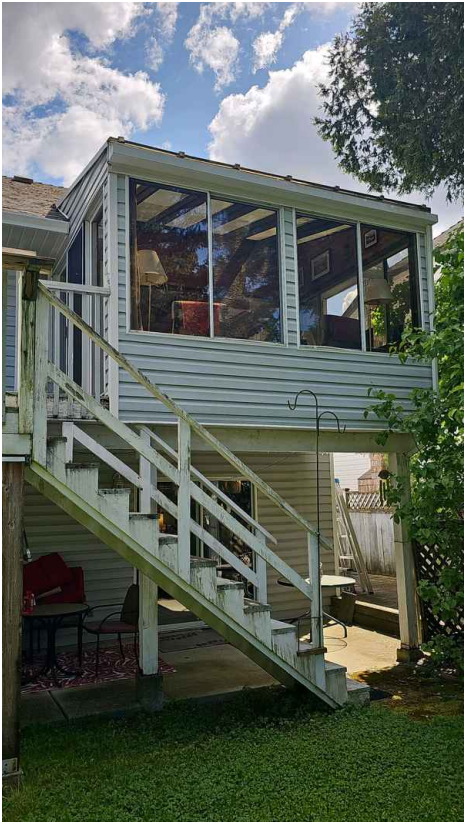
**Porch, Patio, Deck & Balcony: Deck converted to Sunroom**

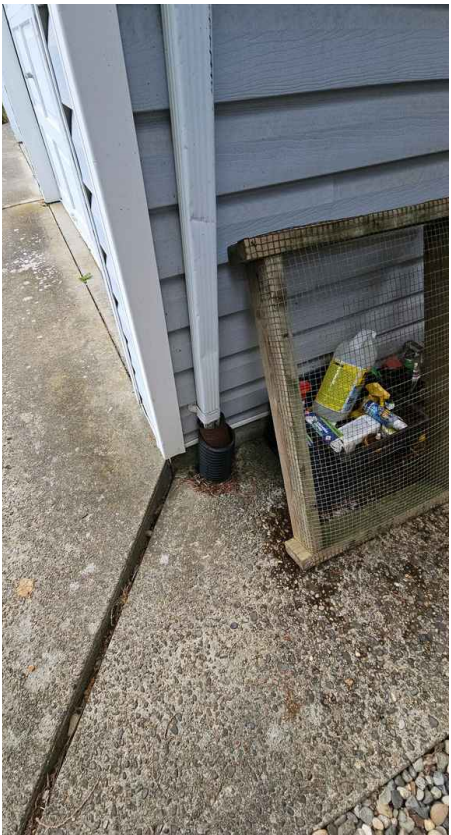
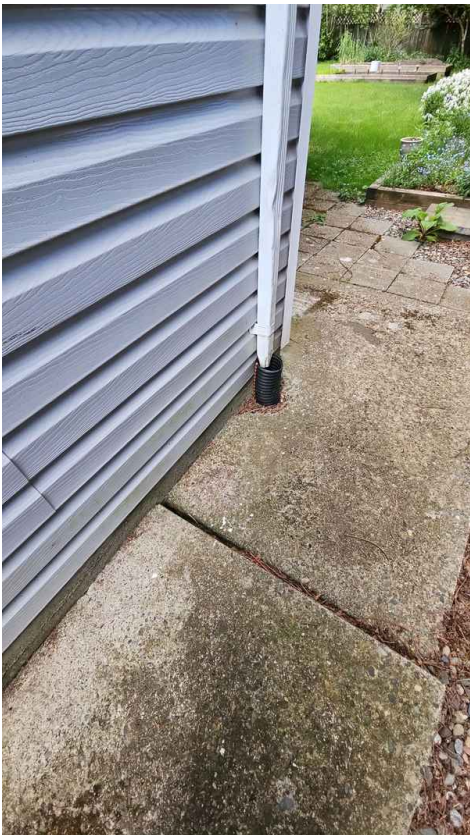
Downspouts / Discharge: Discharge Level  
Under Ground

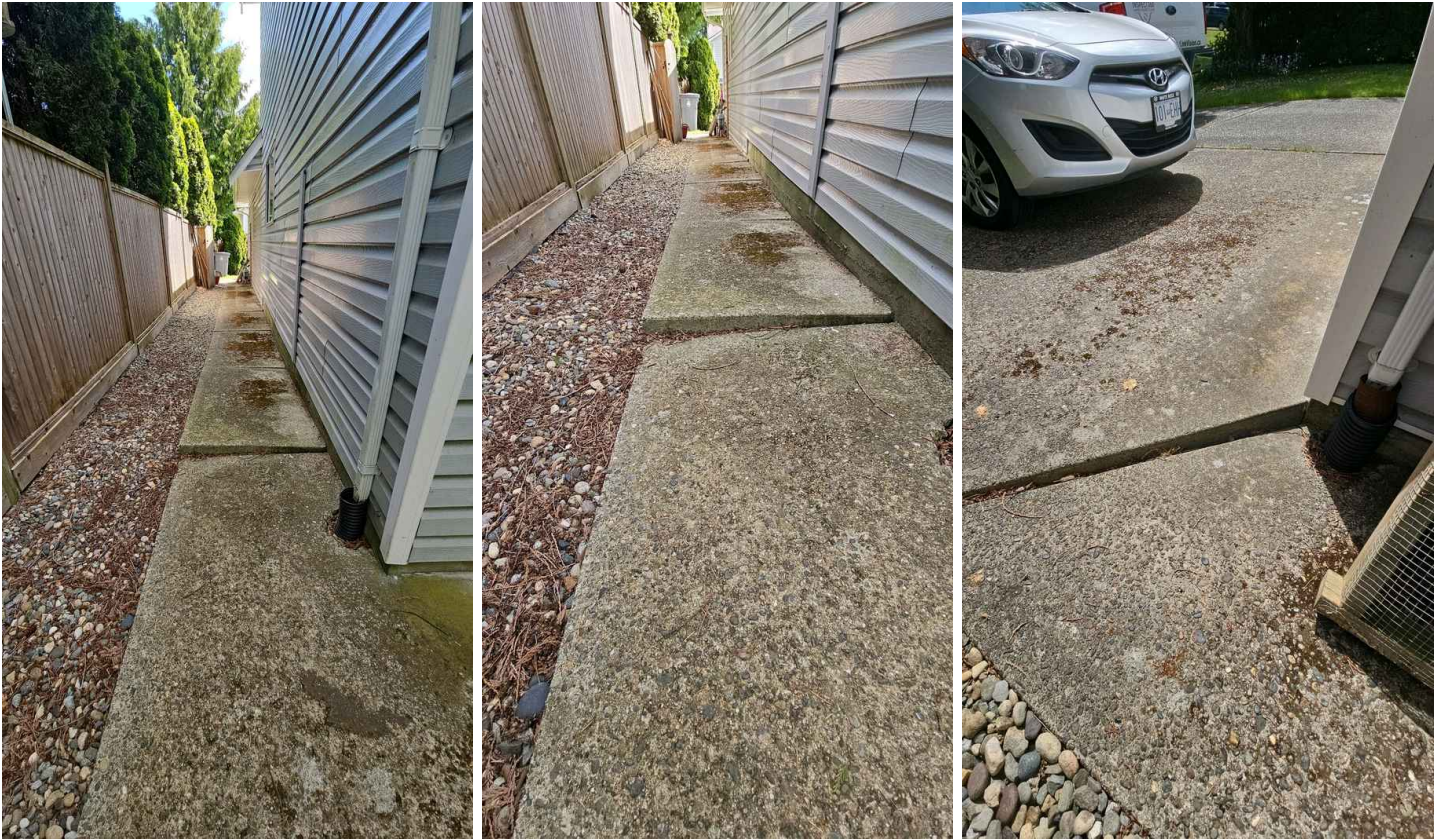
4.3.1 Walkway

Trip hazard. Probable cause is collapse of Corrugated drainage tile, and/or soil erosion under the slab.  
Recommend repairs before use of the area. Consult a qualified contractor upon possession for repairs.

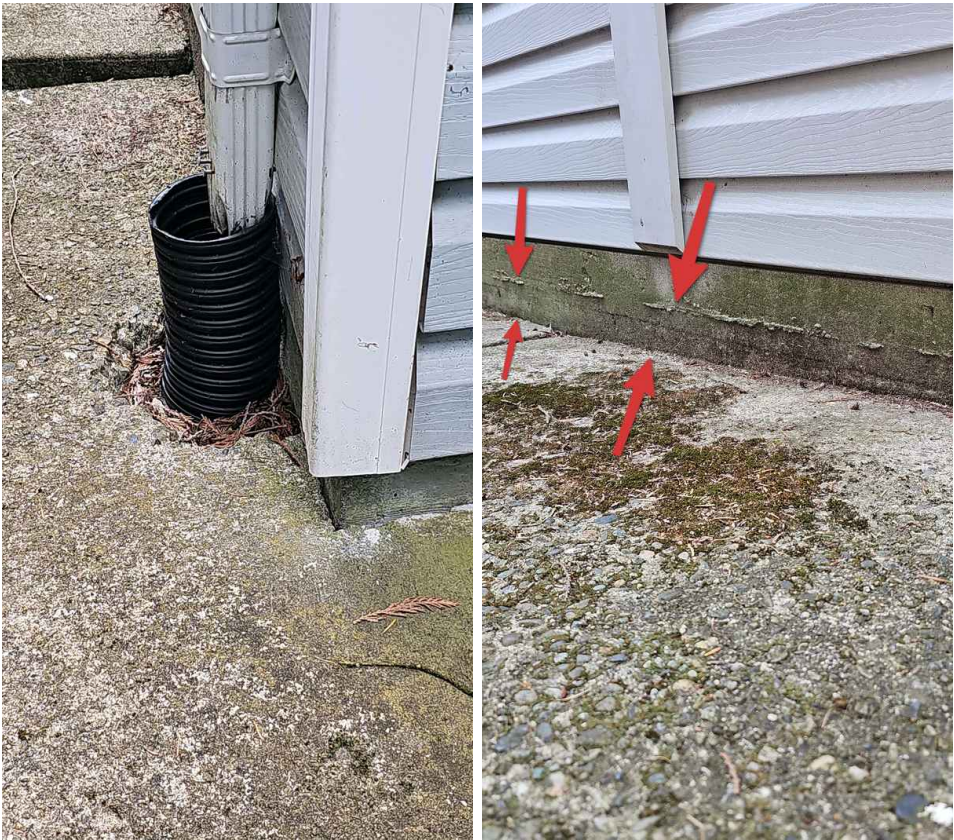
4.6.1 Downspouts / Discharge

Corrugated black plastic drains, also known as Big-O drains are prone to collapsing under the weight of the soil. This can lead to ineffective perimeter drainage causing potential for water ingress through foundation cracks.

The walkway on the right side of the building appears to have settled by about 4-5 inches, which could indicate a collapsed drainage tile.

Recommend further evaluation before subject removal.

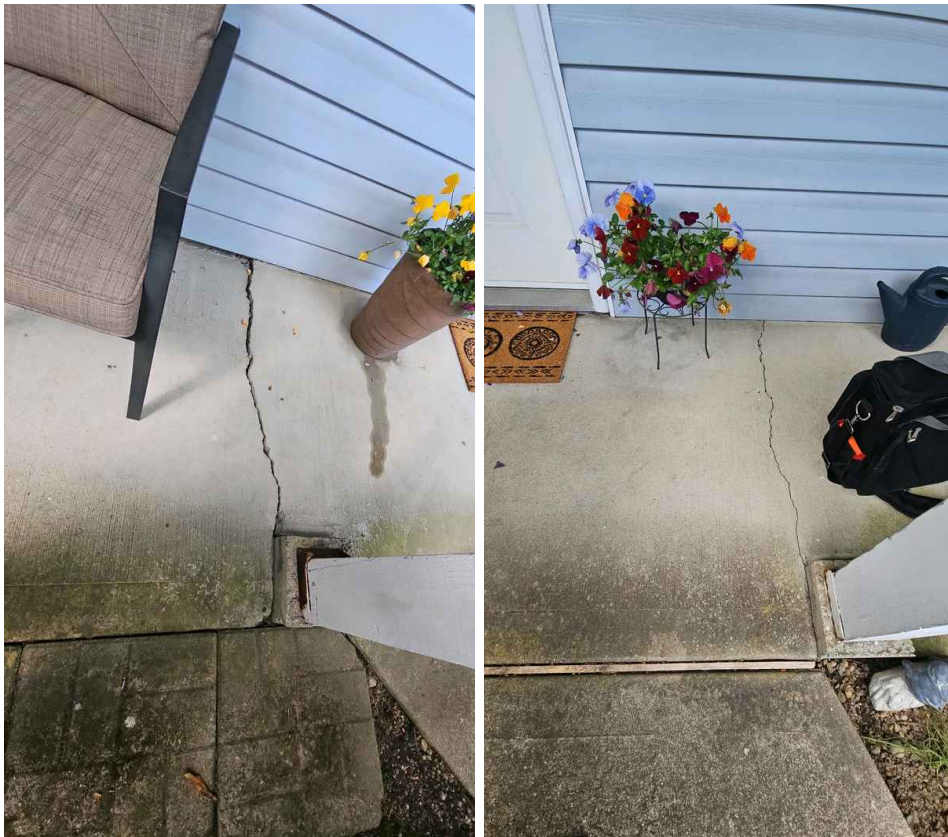
##### **CRACKS/SETTLEMENT.**

Minor cracks in concrete are acceptable.  
Monitor for expanding cracks and/or settlement related issues.  
Consult a concrete specialist to repair and seal cracks to prevent further damage.

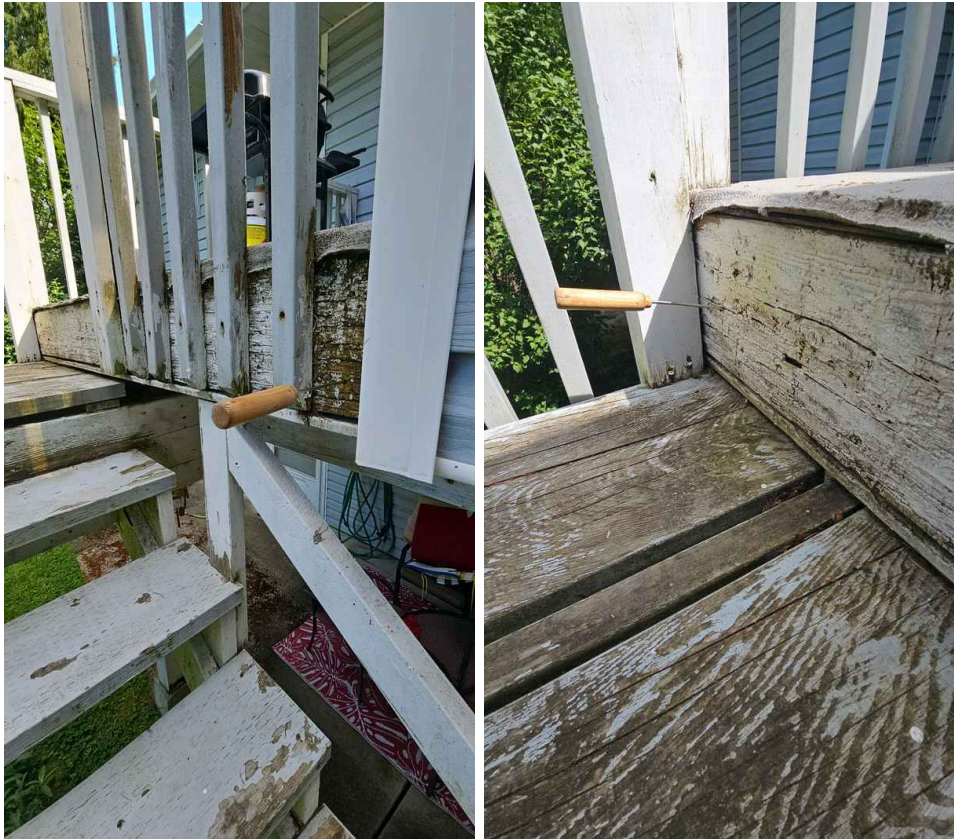
#### 4.12.2 Porch, Patio, Deck & Balcony

##### **DECK - WOOD ROT / CRACKED BOARDS.**

I observed wood rot at the deck. Replace damaged parts and paint /stain to protect on ongoing basis.  
Trip hazard.

Contact a qualified deck contractor.

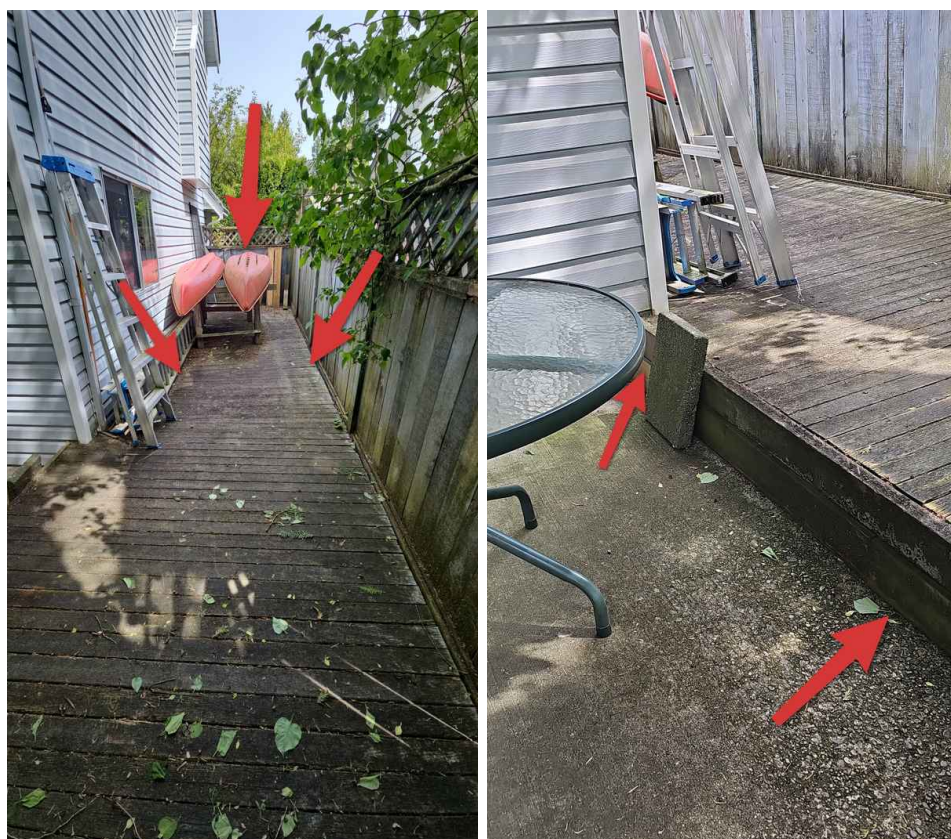
## 4.12.4 Porch, Patio, Deck &amp; Balcony

**DETERIORATED CONDITION AT DECK**

Deck Rot / Construction Suspect

Implication(s): Safety issues, repairs/replacement may be expensive

Repair/replace before use, or eliminate.

Further evaluation by a qualified deck contractor before subject removal as a replacement can be expensive.

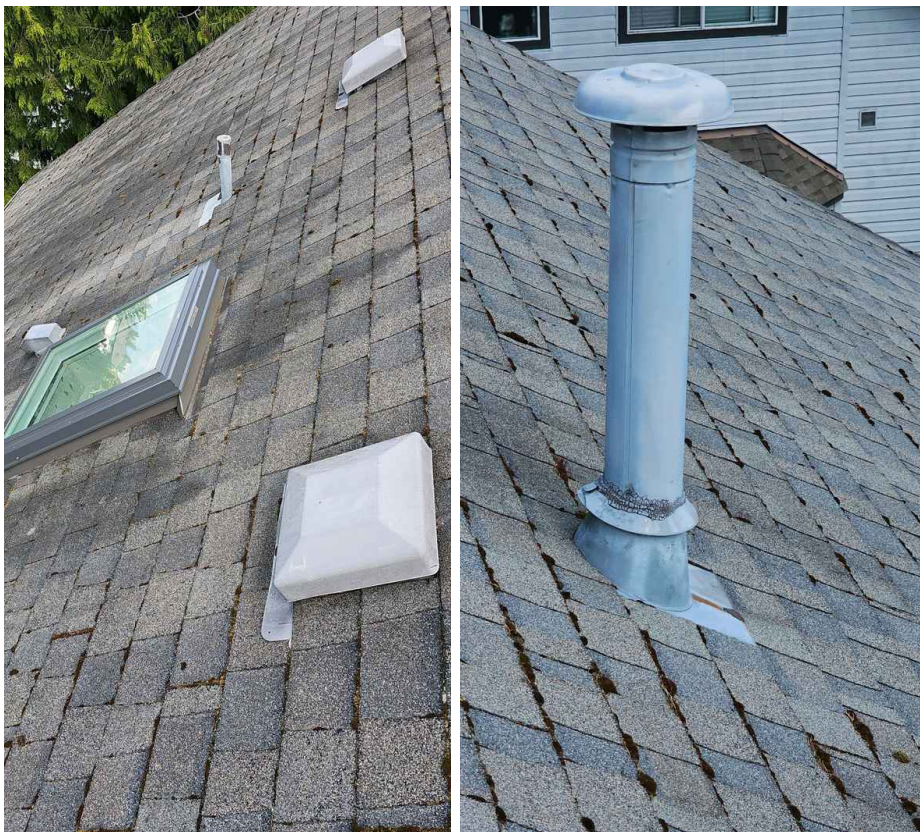
**Roof penetrations and flashing**

**Roof Penetrations: Roof Penetrations.**

Monitor the flashing around the plumbing and gas vent pipes that pass through the roof surface. Sometimes they deteriorate and cause a roof leak. Replace when reroofing.

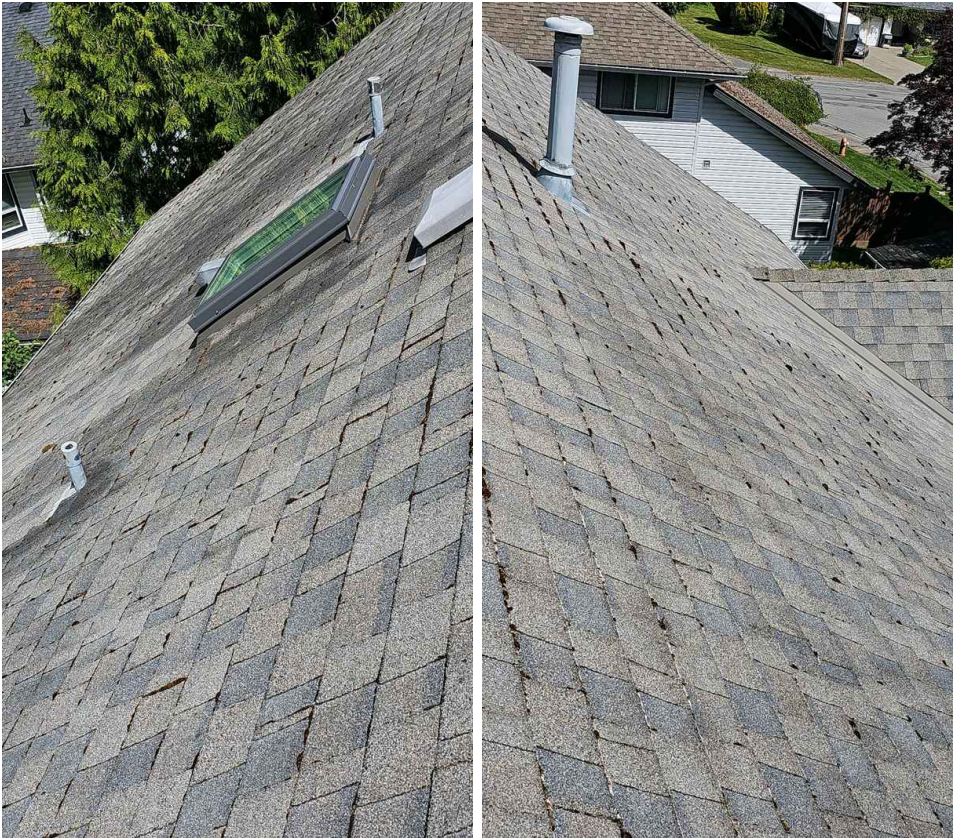
MOSS ON ROOF

Moss / debris on roof can cause water moisture ingress into the structure, causing damage. Moss can also block the roof drainage.  
Consult a professional for cleaning before winter or as soon as possible.

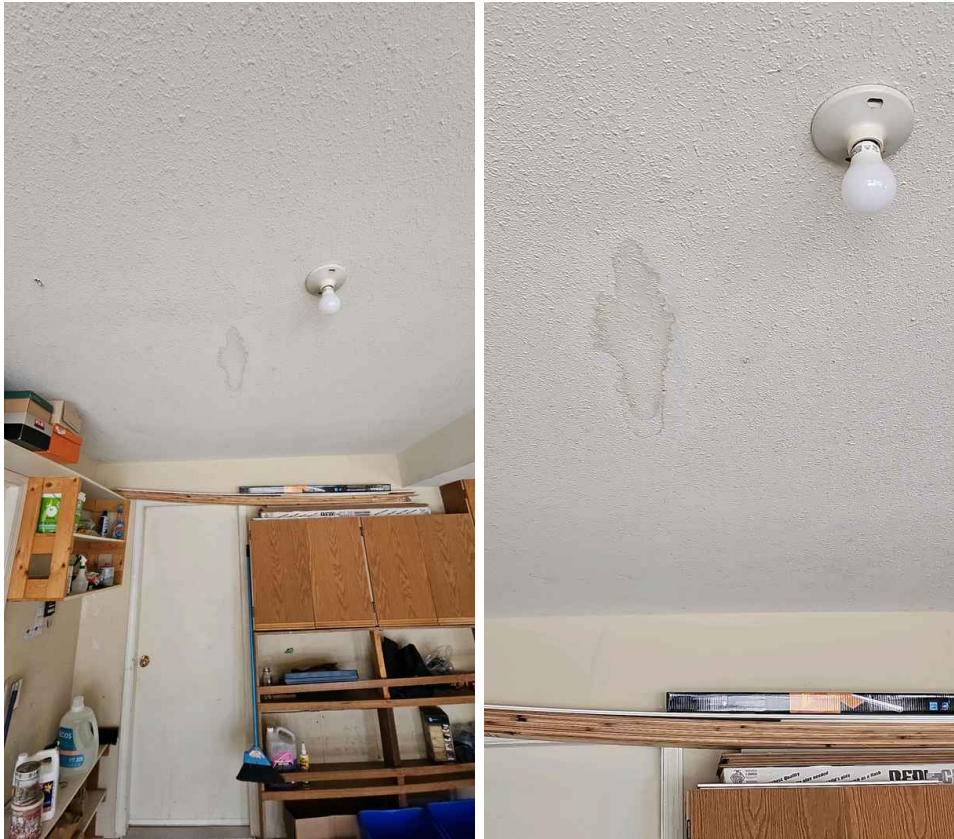
MOISTURE DAMAGE

Garage ceiling shows signs of moisture intrusion. To prevent further damage or growth of mold, I recommend a qualified contractor evaluate and rectify the leak immediately. Water ingress can lead to structural damage, drywall damage, mold growth and health concerns.

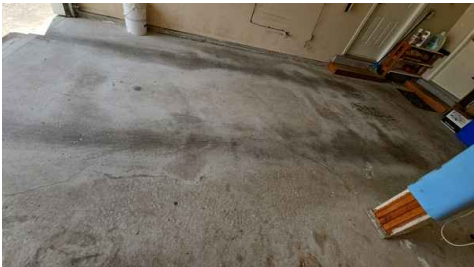
6.3.1 Floor

MINOR CRACKING

Minor Cracks are considered normal for garage floors. They can lead to water ingress from ground below. Consult a concrete repair specialist to seal the cracks with epoxy before winter.

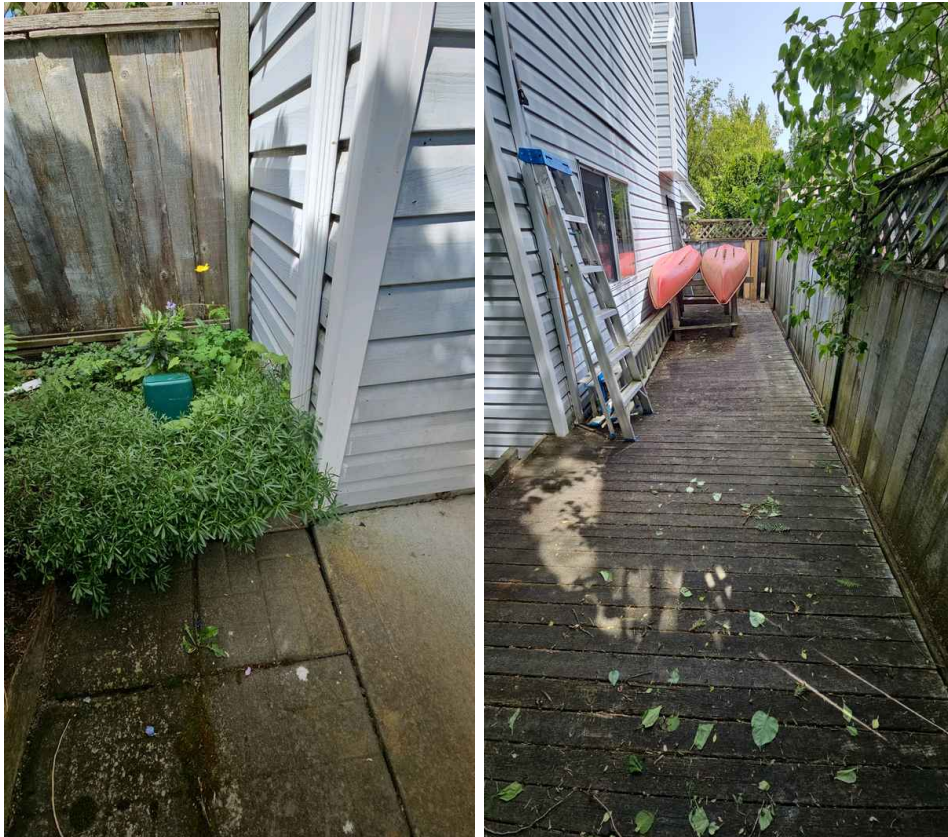
## FOUNDATION WALLS NOT VISIBLE

Foundation walls are covered with wall finishes. Not visible for inspection.

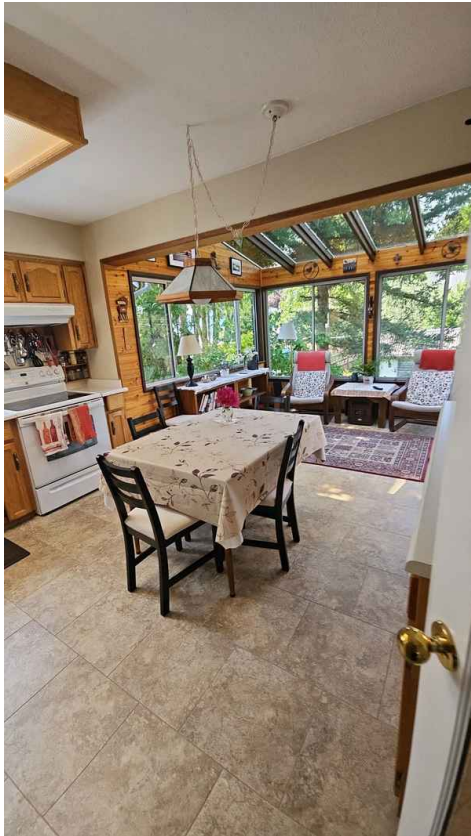
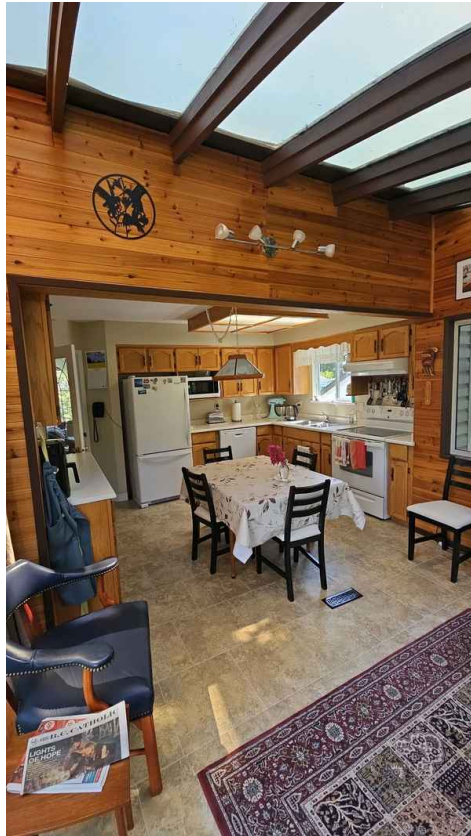
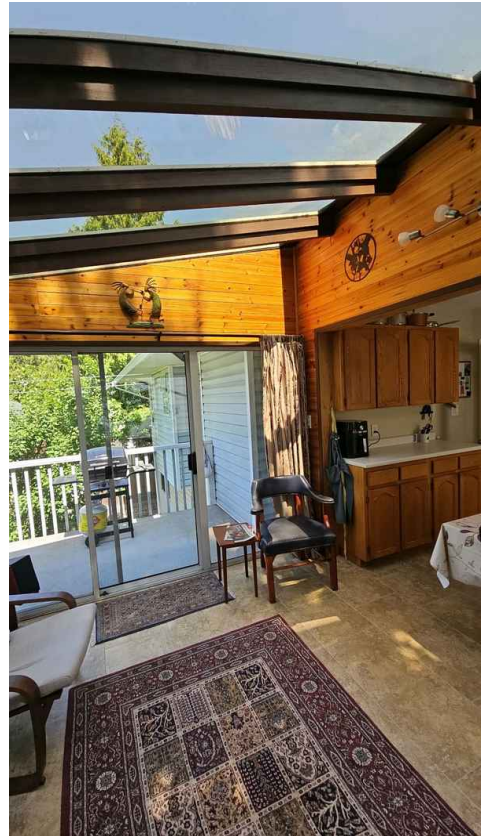
## 7.2.1 Foundation/Structure

The kitchen area has been extended and the space above the deck has been converted into Interior space. No performance issues were noted at the time of inspection.

Please ask current owners regarding permits for the work done as it can be expensive to undo any illegally built sections. Renovations could become expensive.

Consult current owners or their agents before subject removal.

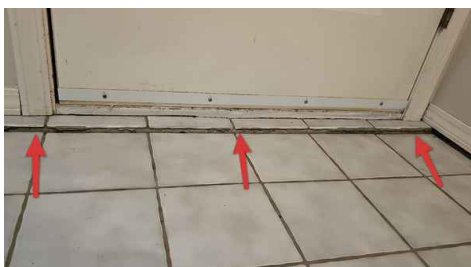
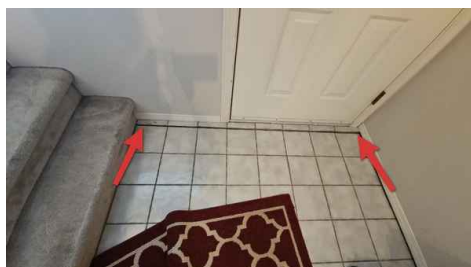
## 7.5.1 Floor Structure

**CONCRETE SLAB SHIFTING/CRACKING**

Concrete slab was found to be shifting/cracking at the floor structure. This can be caused by moisture intrusion and/or soil movement. Recommend a structural engineer evaluate and repair to preserve structural integrity of the home.

IMPLICATIONS: Weakened structure, expensive repairs.

TIMELINE: Before Subject removal.

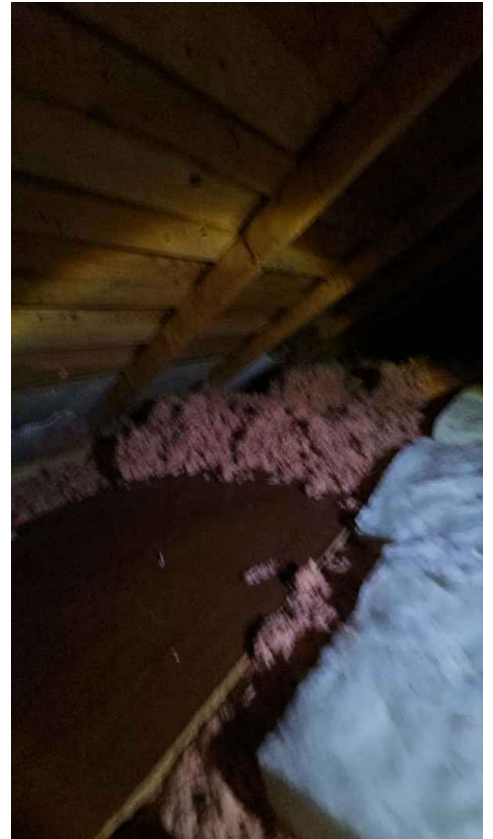
**DISTURBED / IMPROPER INSTALLATION**

Several gaps from foot traffic noticed in the attic insulation. Heat loss into the attic can increase the heating costs. Warm air in the attic can introduce moisture related issues to the attic. Consult a HVAC specialist to add / distribute the insulation to current standards upon possession.

Contact a qualified insulation contractor.

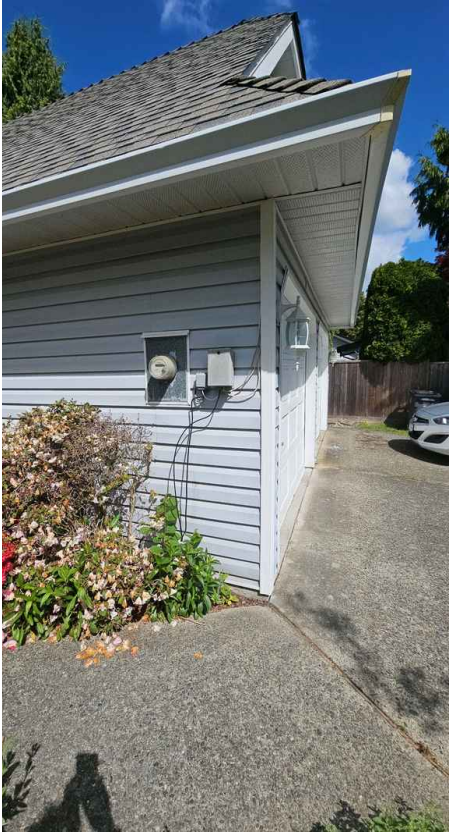
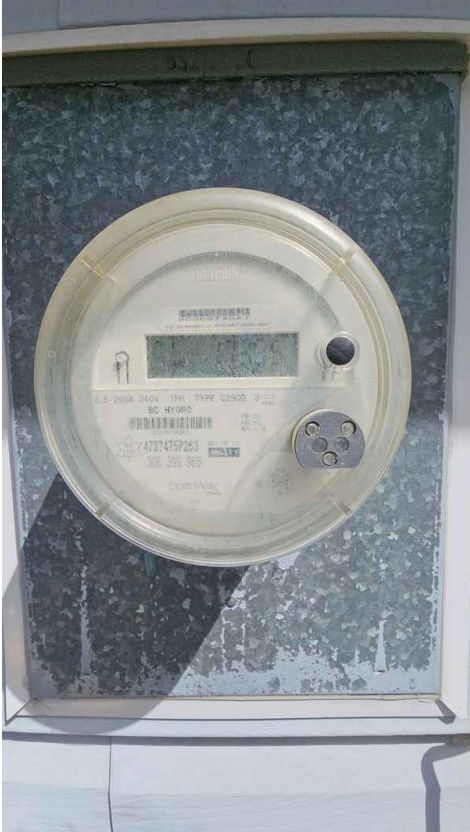
Service Entrance: Meter Location

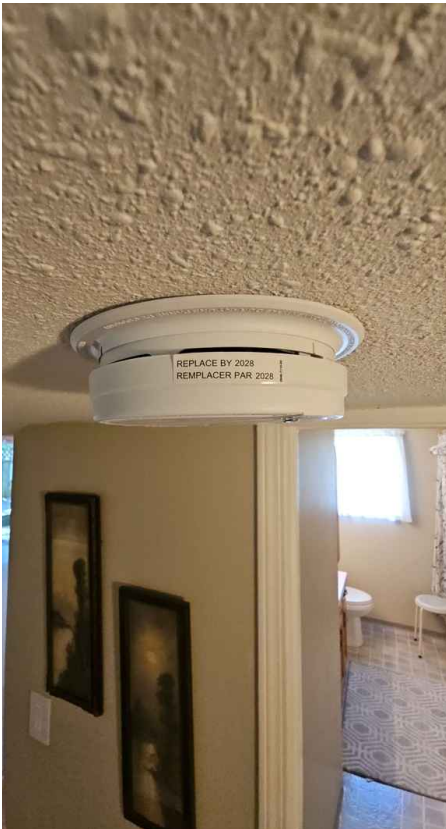
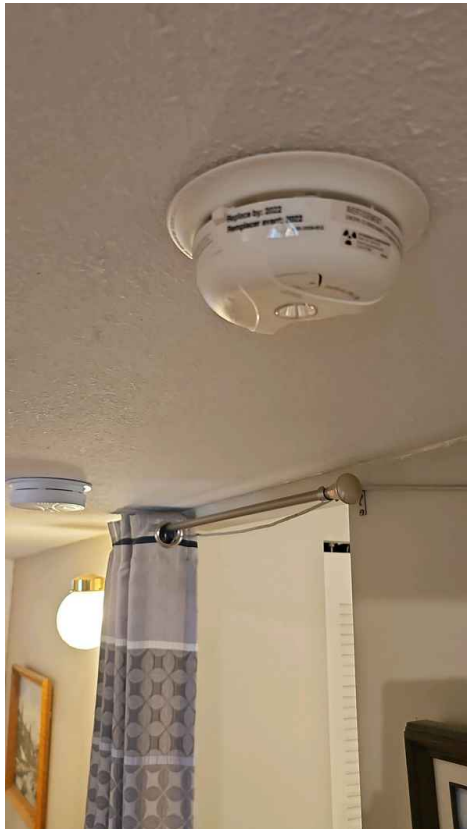
**Smoke Alarm: Installed**

Smoke alarms have a useful life of 10 years. If no date is marked on the smoke alarm, they are assumed to be original to the building.

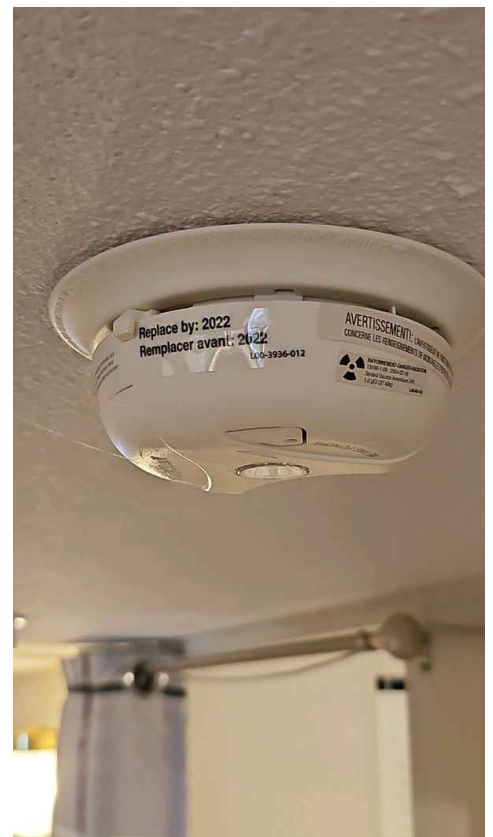
#### 9.4.1 Smoke Alarm

The current standards mandate the installation of a smoke alarm in every bedroom and living area, as well as a Carbon Monoxide (CO) detector on each floor that houses combustion appliances. Smoke and Fire alarms have a expected life of 10 years and should be replaced after that time.

Consider replacing all smoke and CO detectors upon possession so you are certain about their age and operational condition.

Contact a qualified electrical contractor.

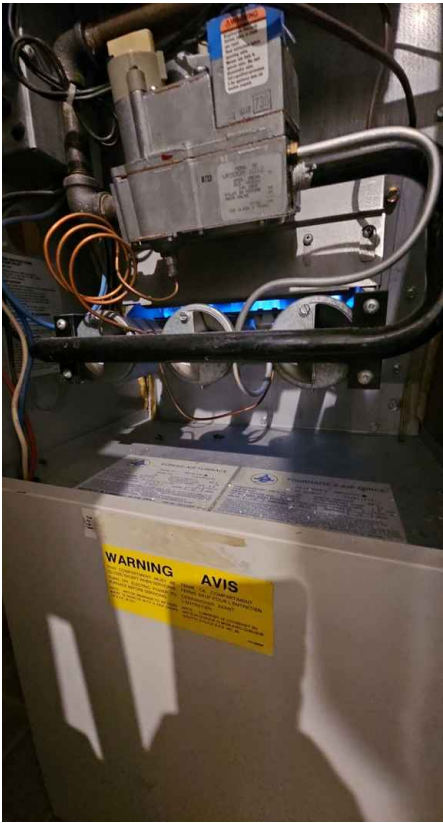
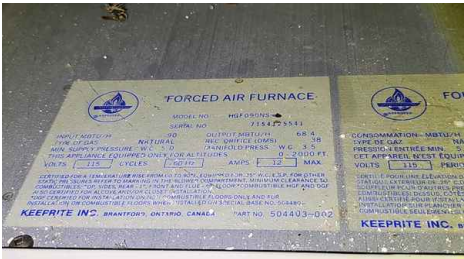
Furnace / Boiler: Approximate  
Age

25+  
The furnace appears to be original to the building. Mfg date 1987

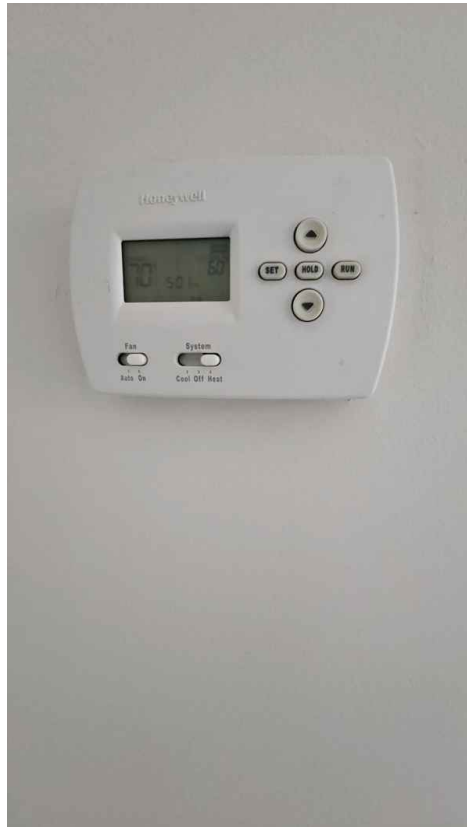
## 1st floor Hallway

**General: Thermostat Location**

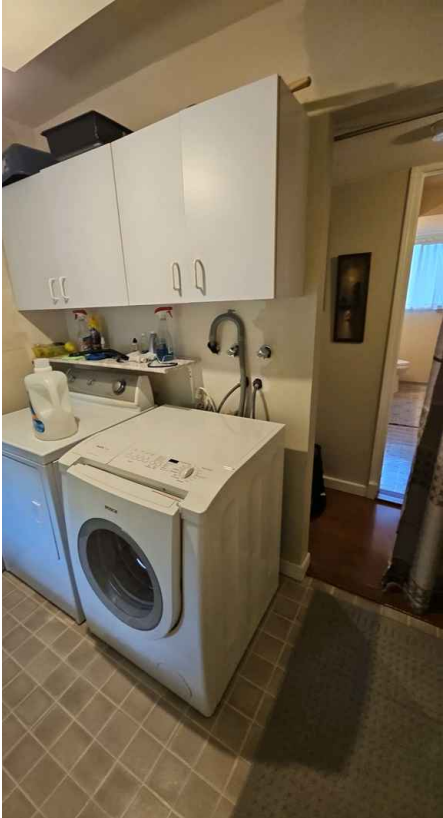
**Laundry unit: Location**  
Utility room

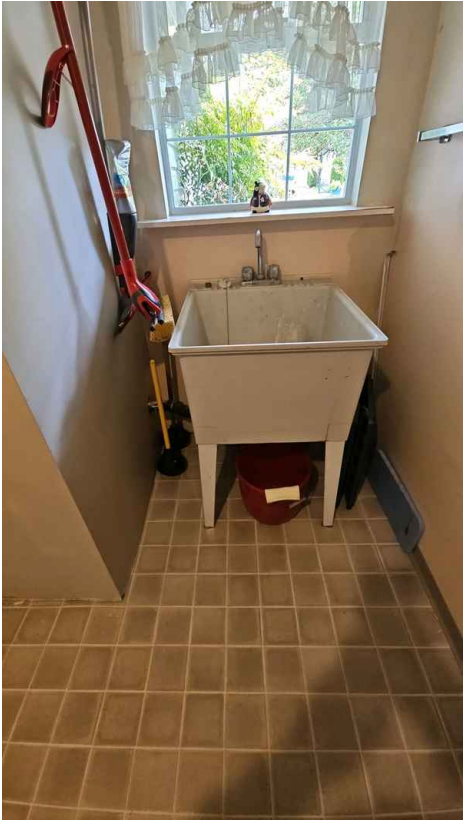
**Laundry unit: Laundry Sink**

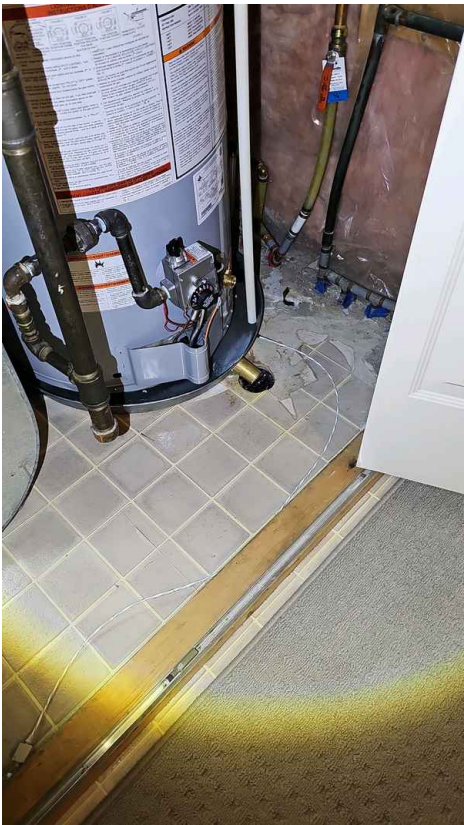
**Floor drain: Location**  
Near water heater

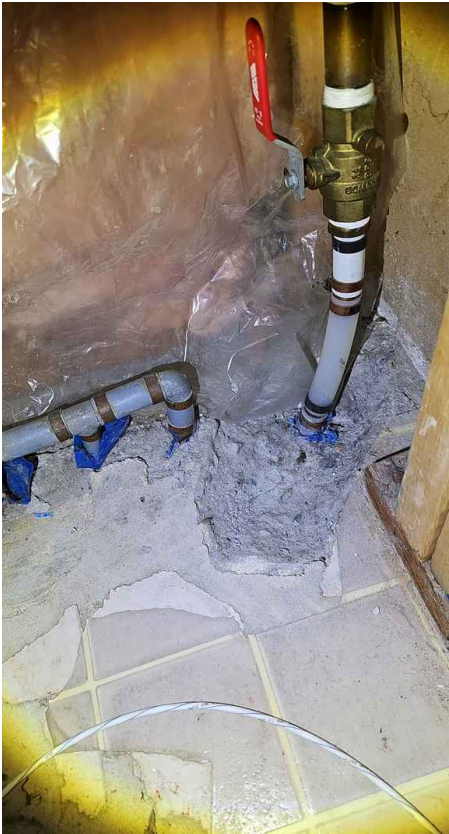
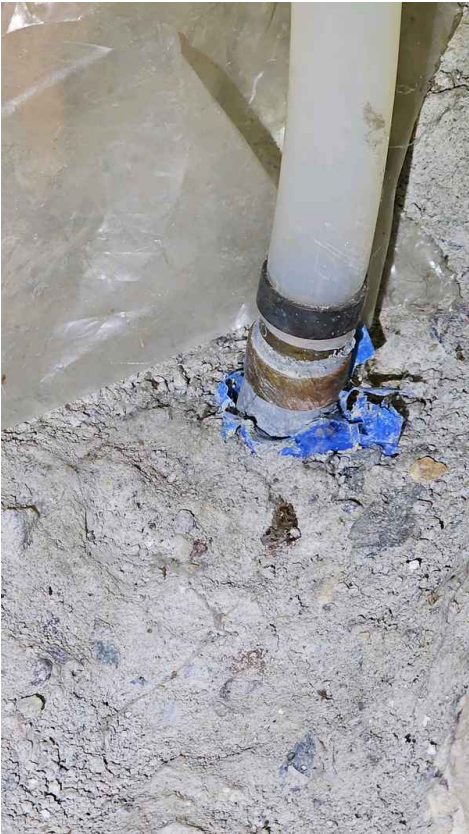
**Main Water Service: Main supply line material**  
Pex, Poly-B

**Main Water Service: Water Supply inside the house**

Poly-B

Condition: This home has Poly B piping which was discontinued due to a history of failing.  
Implication(s): Water leaks can damage contents, materials, structure and may cause mould. Re-piping may be expensive. Possible insurance issue. Possible hidden damage.  
Location: Various/Throughout  
Recommendation/Task: Discuss with insurance company. Consult a plumber regarding the condition of the piping and possible re-placement requirements.

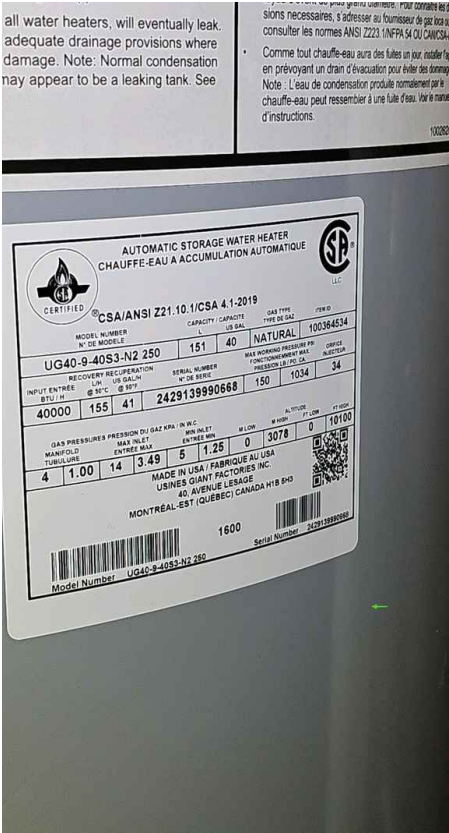
Estimated water heater life span is 8 to 12 years.

Manufacture Date derived from serial number:

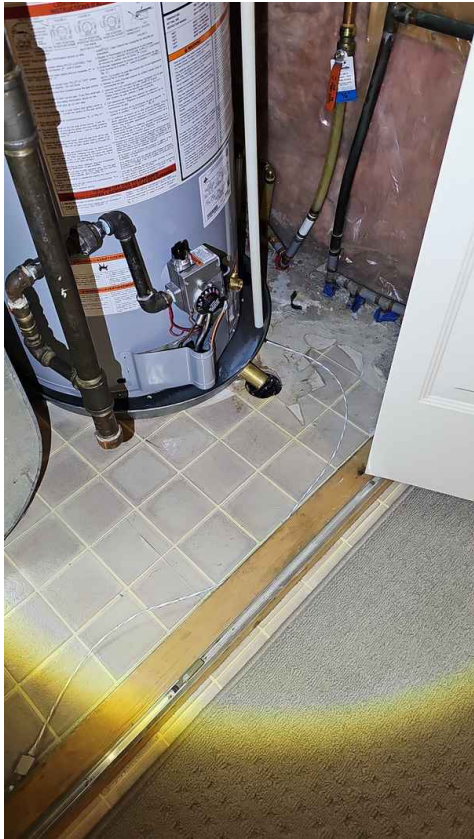
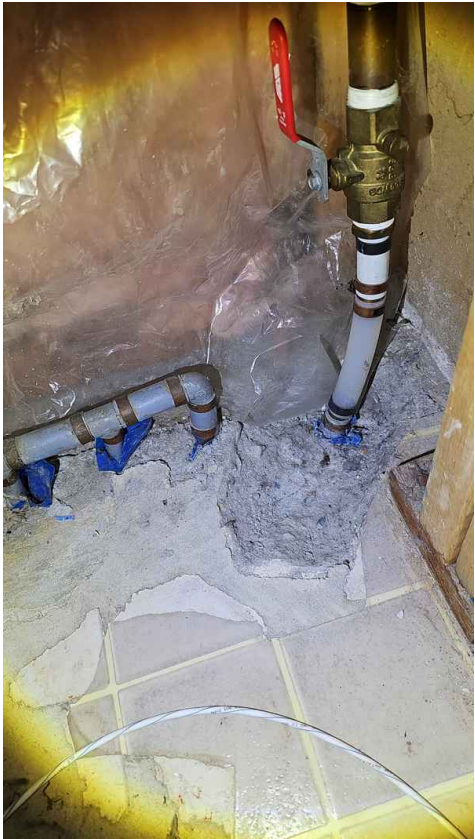
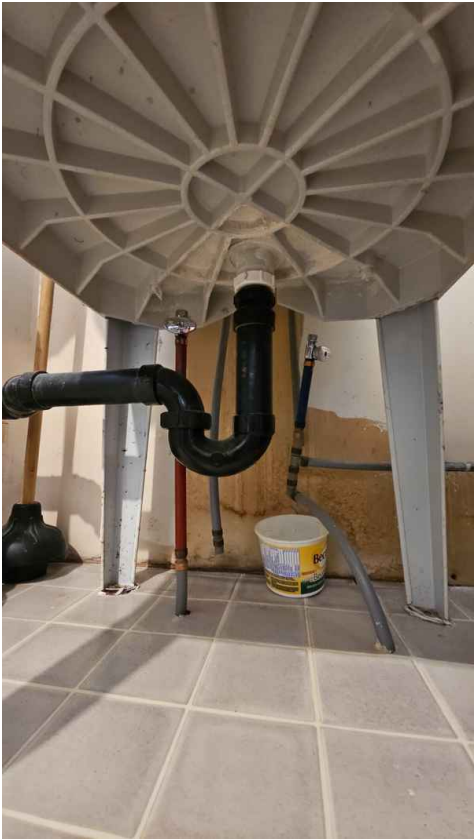
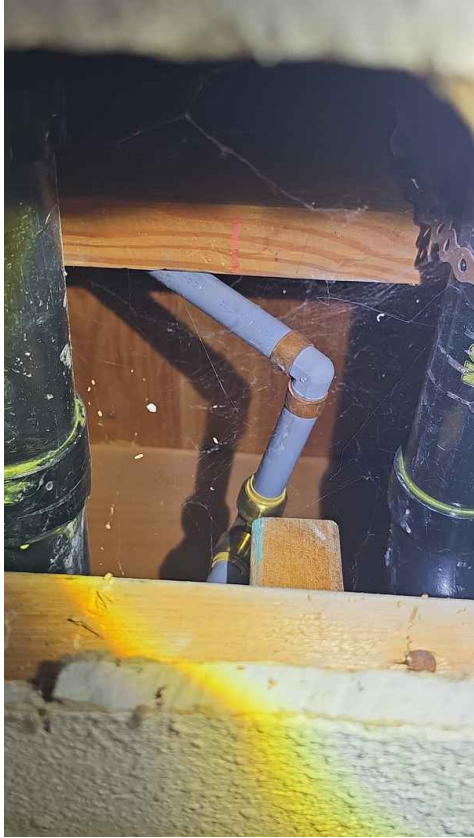
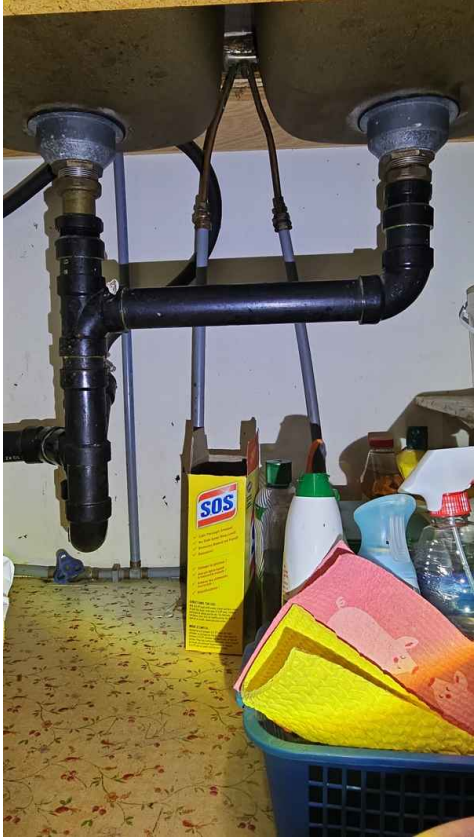
11.4.1 Water Heater  
**NO EXPANSION TANK**

No expansion tank was present. Expansion tanks allow for the thermal expansion of water in the pipes. These are required in certain areas for new installs. Recommend a qualified plumber evaluate and install upon replacement of water heater.

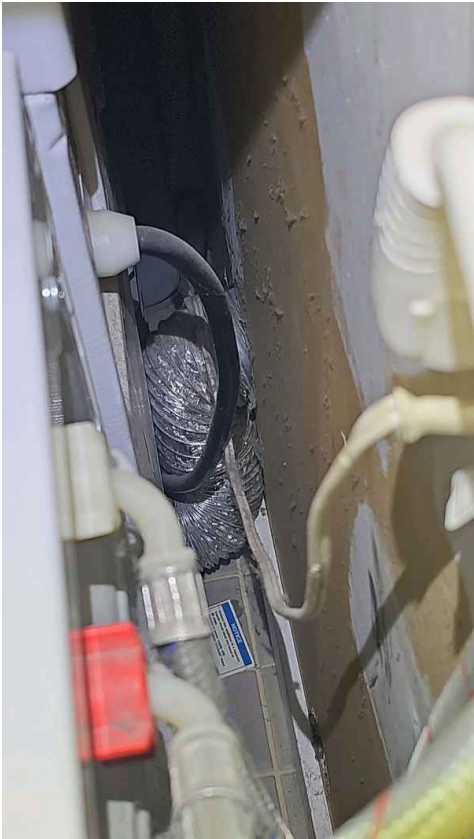
#### 11.5.1 Laundry unit

### DRYER VENT MATERIAL

Recommend replacing flexible ducts with rigid material ( Metal ducting). Flexible ducts can trap lint and/or melt with heat causing a fire hazard. Dryer lint is a highly inflammable material.

Do not allow a sag in the flexible pipe that becomes a lint trap, causing a fire hazard.

Consult a professional to replace as soon as possible upon possession.

Recommendation  
Contact a qualified HVAC professional.

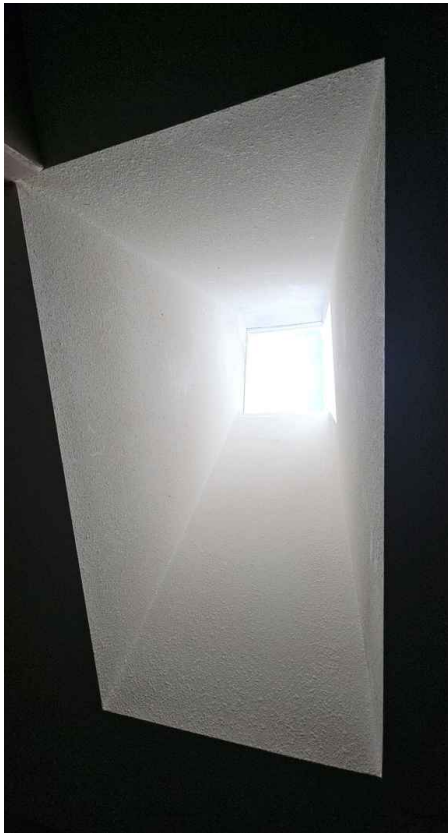
**Skylight: Skylight type**

Fixed

Skylights are notoriously problematic and a common point of leaks. It is important to keep the area around the skylight free of debris and to monitor it for evidence of water leaks during heavy rains and/or winter snow melts.

Skylights over 10 years old are prone to leaks and you should consider replacement at the first sign of water ingress.
