# INSPECT360 HOME INSPECTIONS

1234 Main Street  
Port Coquitlam, BC V3B5T8

11/25/2025 9:00AM

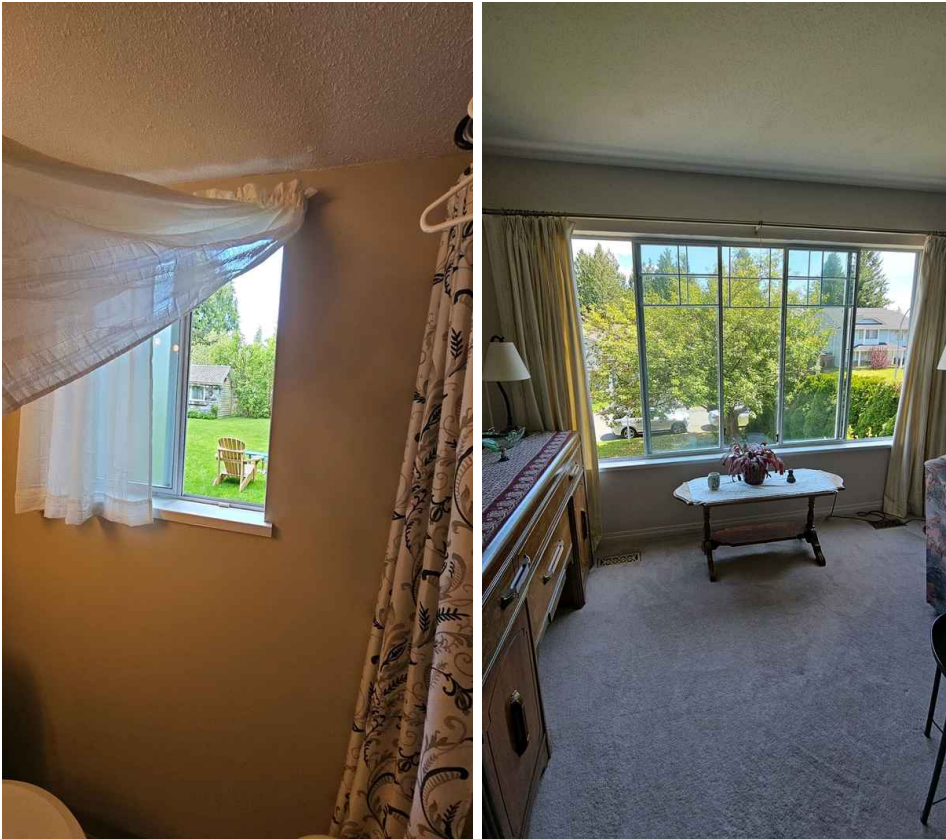
**MISSING SCREEN**

Window missing screen can cause insect / pest ingress. Recommend getting replacements upon possession.

Contact a qualified window repair/installation contractor.

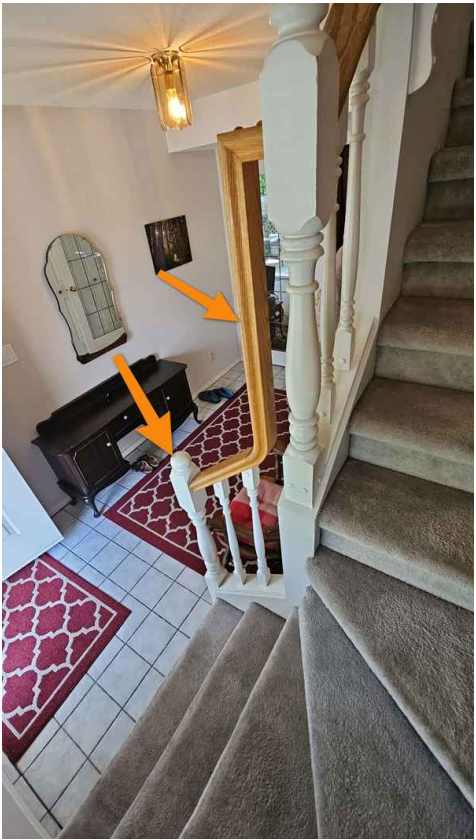
12.6.1 Stairs / Steps / Railings

**LOOSE HANDRAIL**

Loose handrails can present a fall and injury hazard.  
Consult a contractor for immediate repairs.

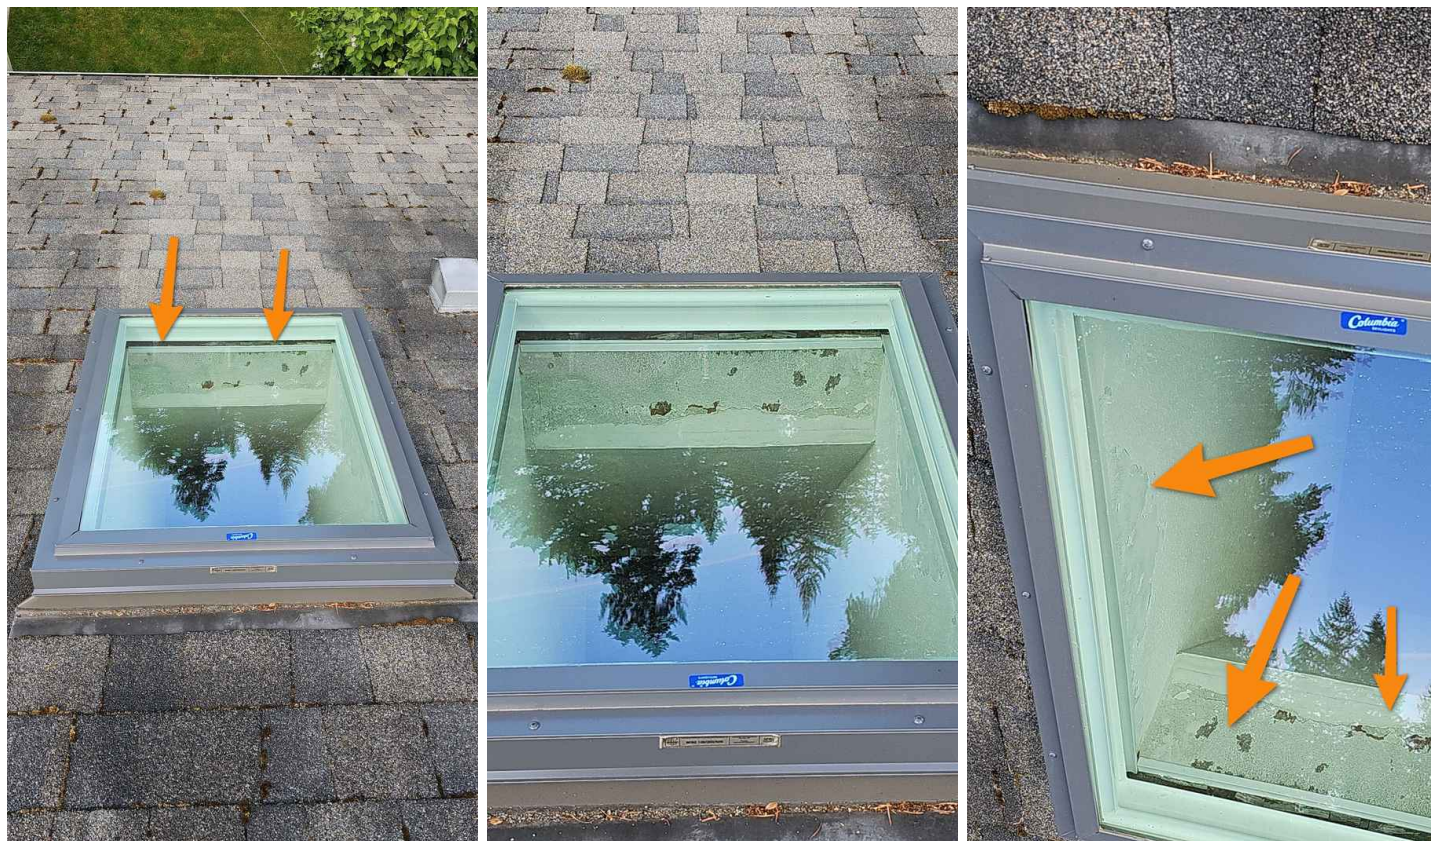
## 12.8.1 Skylight

**SKYLIGHT**

Some concerns were noted with the skylight when observing from the roof. There are signs of wood rot and drywall repair. Old skylights can leak due to design issues and should be replaced with updated models upon roof replacement, or if any moisture ingress issues are noted.

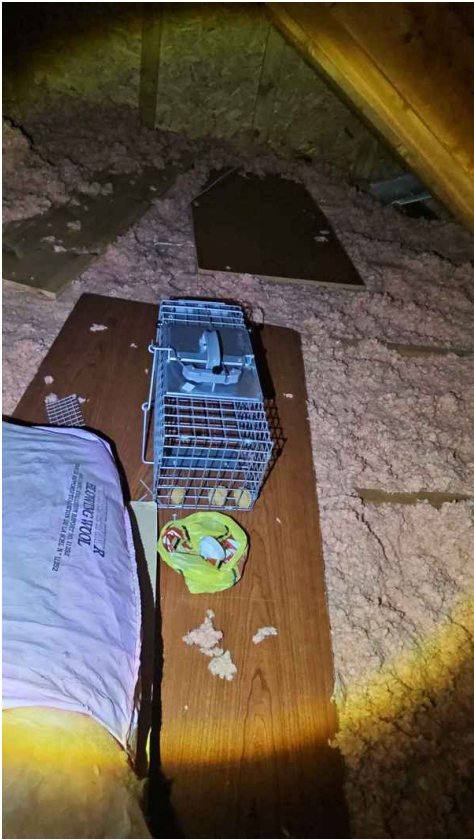
**TRAPS OBSERVED.**

Pest traps were observed in Various locations around the building indicating an ongoing pest issue.

Recommendation  
Contact a qualified pest control specialist.

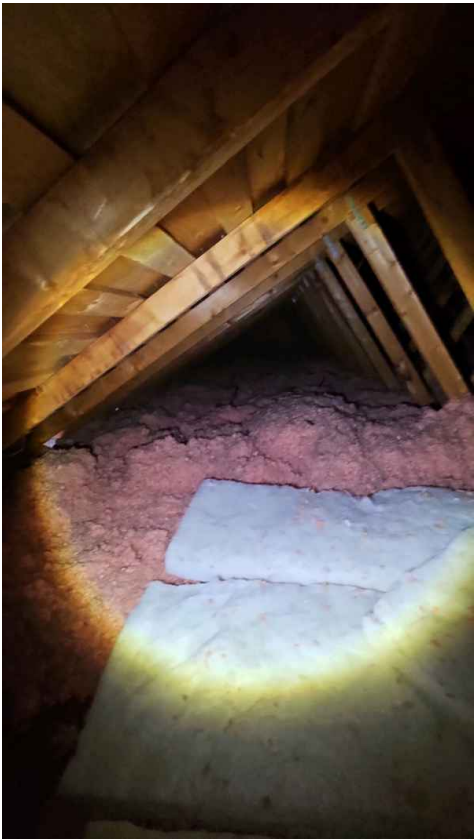
12.9.3 Pest Control

**RAT TUNNELS**

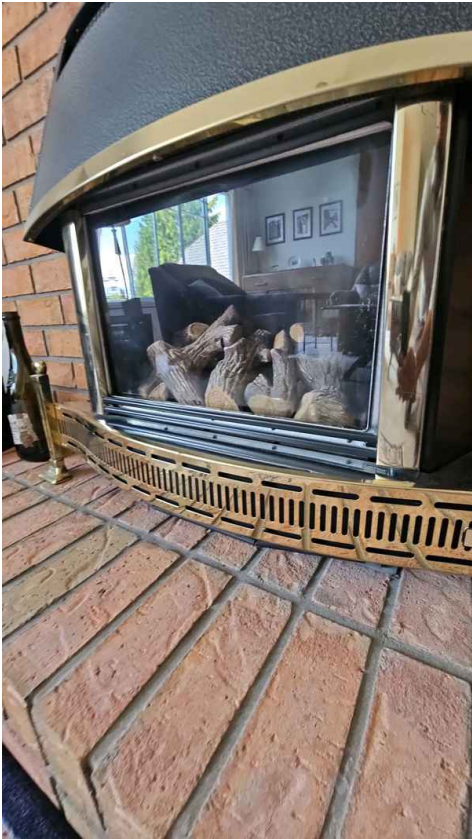
General  
**PILOT LIGHT NOT ON**

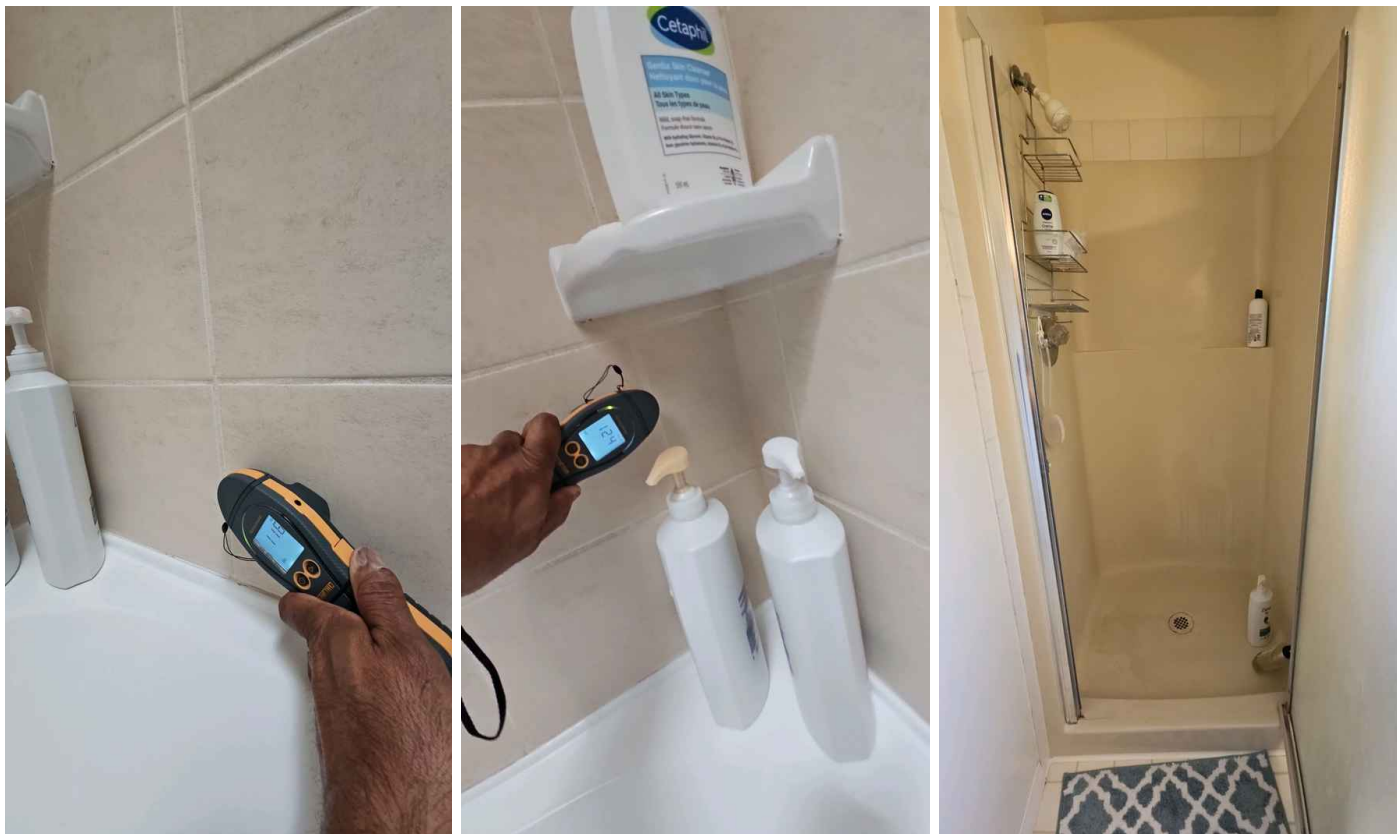
**Bathroom Toilets: Apply sealant and caulking.**

Throughout

Sealants and caulking can deteriorate over time or be dislodged with shrinking or expanding of structure.

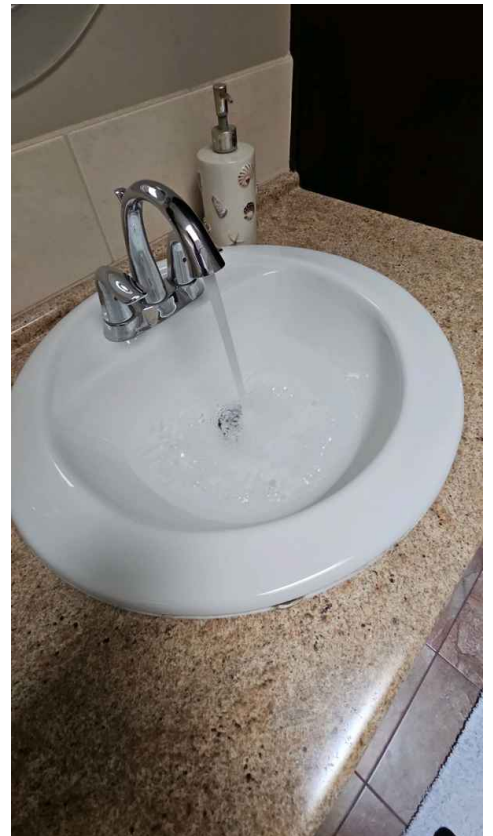
## 14.3.1 Sinks / Faucets / Countertop

The sinks drain slow, causing a potential for overflow and flooding causing damage to structure and contents.

Consult a plumber for repairs immediately upon possession.

Contact a qualified plumbing contractor.

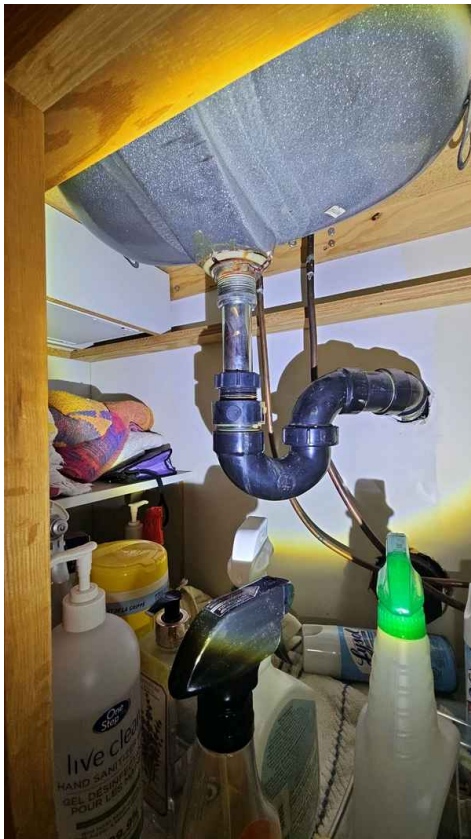
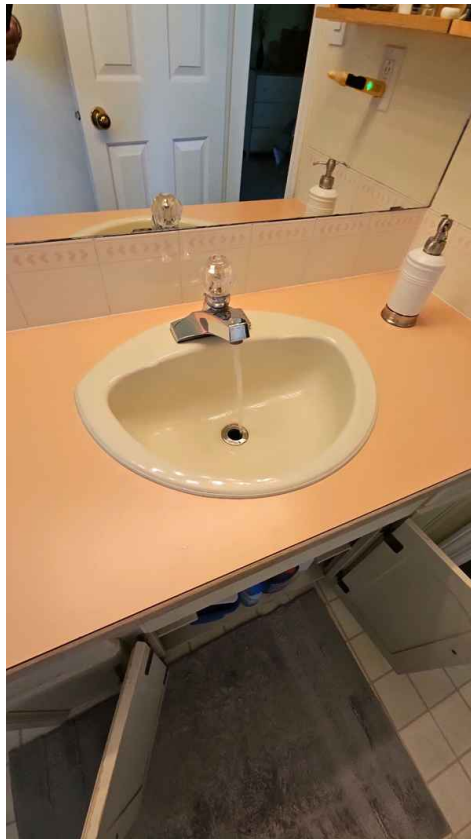
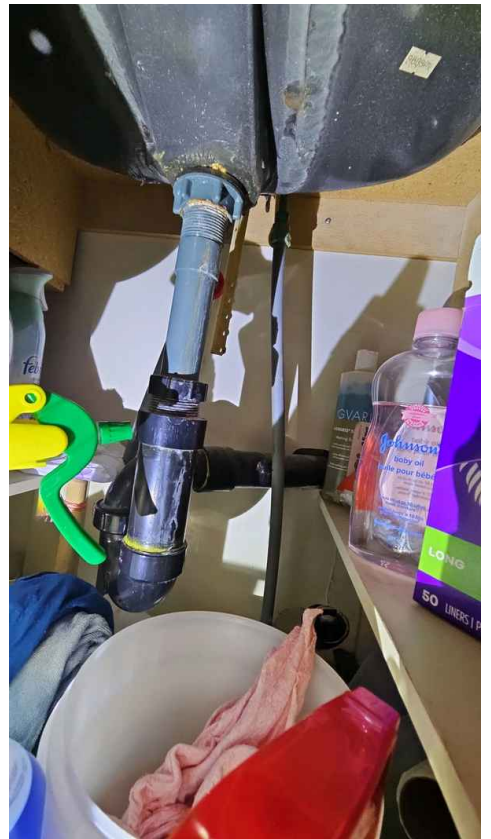
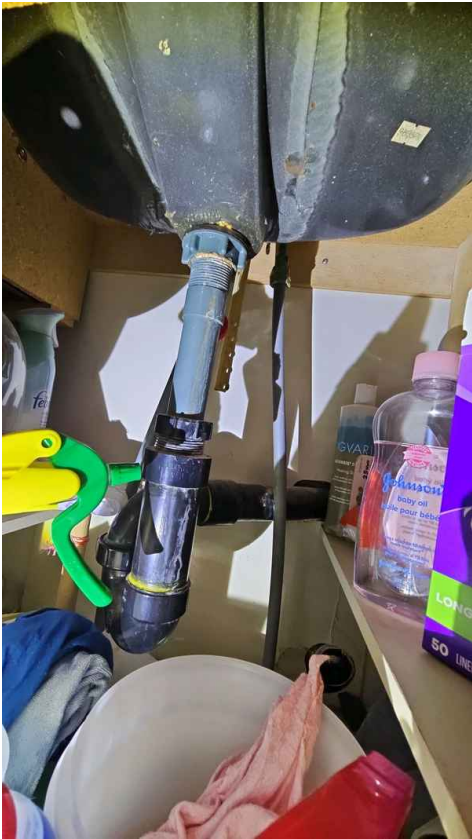
**RUSTED SINK.**

The metal sink has rust at the bottom. This could indicate issues with prior or current water leaks. A rusting sink could fail unexpectedly, potentially causing water ingress for the cabinet and structure below, causing hidden damage. Consult a plumber upon possession, before use.

Contact a qualified professional.

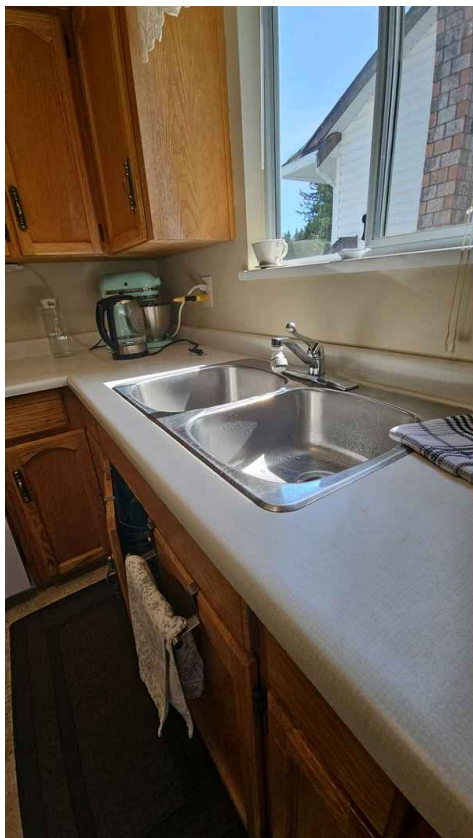
## 15.2.2 Faucets / Sinks / Countertop

**APPLY SEALANT AND CAULKING.**

Sealants and caulking can deteriorate over time or be dislodged with shrinking or expanding of structure. Check and apply sealants on ongoing basis at all joints and around the sink in Kitchen.
